# Natural Stone and Architectural Heritage

Edited by  
Lola Pereira, Lidia Catarino and Giovanna Antonella Dino  
Printed Edition of the Special Issue Published in *Sustainability*

Special Issue Editors

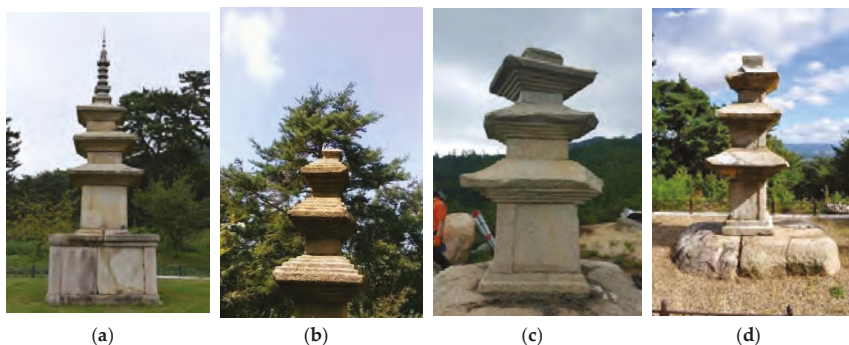
**Figure 2.** Typical damages to stone pagoda caused by 9–12 Gyeongju Earthquake (Photo by NRICH): (a) Separated third-story body stone, three-story Stone Pagoda at Cheollyongsa Temple Site in Namsan Mountain; (b) Rotated stone member, displaced third-story body stone, three-story Stone Pagoda of Yongjanggye Jigok Valley in Namsan Mountain; (c) Rotated body and roof stones, three-story Stone Pagoda of Bipagok Valley in Namsan Mountain; and (d) Displaced third-story body and roof stones, three-story Stone Pagoda of Jiamgok Valley in Namsan Mountain.

The 9–12 Gyeongju Earthquake damaged 52 designated cultural heritage sites. Bulguksa Temple suffered considerable damage. For example, roof tiles fell from the Main Buddha Hall (Daewoongjeon), walls in the west corridor were cracked, the fence of Guanyeumheon was destroyed and the banister joints in Dabotap Pagoda were displaced. In Cheomseongdae, the interlocking headstones moved and were partially displaced. Figure 2 illustrates the typical damages to the stone pagoda caused by the 9–12 Gyeongju Earthquake. Table 1 provides an overview of the seismic damage to the stone pagodas due to the Gyeongju Earthquake (modified from Kim et al. [23]). Most of the damaged stone pagodas have three stories and a main body composed of massive stones. Various parts of the pagodas suffered damage including the base, main body and steeple. Serious structural damage was not observed, and most damage included cracking, separation and displacement of non-structural members.

**Table 1.** Seismic damage incurred by stone pagodas due to the 9–12 Gyeongju Earthquake.

Classification	Name of Cultural Heritage	Seismic Damage	Height (m)
National Treasure 20	Dabotap Pagoda of Bulguksa Temple	Displaced banister joints	10.3
National Treasure 30	Stone Brick Pagoda of Bunhwangsa Temple	Cracked lower part	
Treasure 168	East and West Three-story Stone Pagodas in Cheongun-dong	Destroyed steeples of the east and west pagodas	East 6.73, West 7.72
Treasure 678	East and West Three-story Stone Pagodas of Unmunsa Temple	Loosen east pagoda roof stone, tilted west pagoda, cracked main body	
Treasure 908	Three-story Stone Pagoda in Yongmyeong-ri	Chipped upper end of main body	5.6
Treasure 1188 (Figure 2a)	Three-story Stone Pagoda at Cheollyongsa Temple Site in Namsan Mountain	Separated third-story body stone	7.16
Treasure 1429	East and West Three-story Stone Pagodas at Wonwonsa Temple Site	Broken east pagoda roof stone	6.04
Treasure 1867	Three-story Stone Pagoda at Changnimsa Temple Site of Namsan Mountain	Cracked base, separated main body, partially broken roof stone	7.0

Treasure 1935 (Figure 2b)	Three-story Stone Pagoda of Yongjanggye Jigok Valley in Namsan Mountain	Rotated stone member, displaced third-story body stone	
Historic Site 311	Archaeological Area of Namsan Mountain (Three-story Pagoda of Yeonbuls Temple Site)	Loosened third-story body stone	7.0
Province-Designated Tangible Cultural Heritage 448 (Figure 2c)	Three-story Stone Pagoda of Bipagok Valley in Namsan Mountain	Rotated body and roof stones (counter clockwise)	
Province-Designated Tangible Cultural Heritage 449 (Figure 2d)	Three-story Stone Pagoda of Jiamgok Valley in Namsan Mountain	Displaced third-story body and roof stones

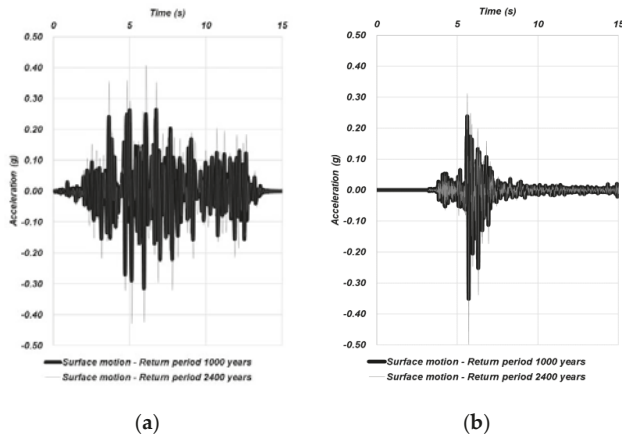
**Figure 4.** Ground response analysis for Cheomseongdae site: (a) Ofunato earthquake motion; and (b) Gyeongju MKL motion.

The frequency range of the shaking table mounted on the centrifuge was 30–300 Hz for the scale model. Hence, the tests were performed at a centrifugal gravitational field of 15 g using a 2–20 Hz prototype-scale component. The time history from the ground response analysis results was converted using the bandpass filter of the 2–20 Hz component. As a result, the  $T_d$  values of the input seismic wave used for actual testing were 11.15 s and 2.46 s for the Ofunato and Gyeongju Earthquake motions, respectively.

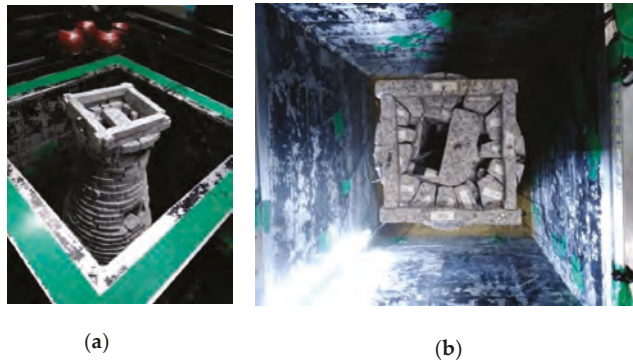
**Figure 5.** Cheomseongdae model: (a) Cheomseongdae model with headstones; and (b) Cheomseongdae model without headstones.

To analyse Cheomseongdae’s seismic behaviour characteristics, 1/15-scale models were created, and dynamic centrifuge model testing was performed using a centrifuge device and shaking table from the KAIST Geo-Centrifuge Testing Center [28,29]. The scaling factors were considered by applying a 15 g centrifugal force vertically, which is 15 times the gravitational acceleration, to the 1/15-scale Cheomseongdae model. Hwangdeung granite was used for the model members because its density and stiffness are closest to those of the material at Cheomseongdae. This enhances the plausibility of reproducing the actual seismic behaviour of Cheomseongdae.

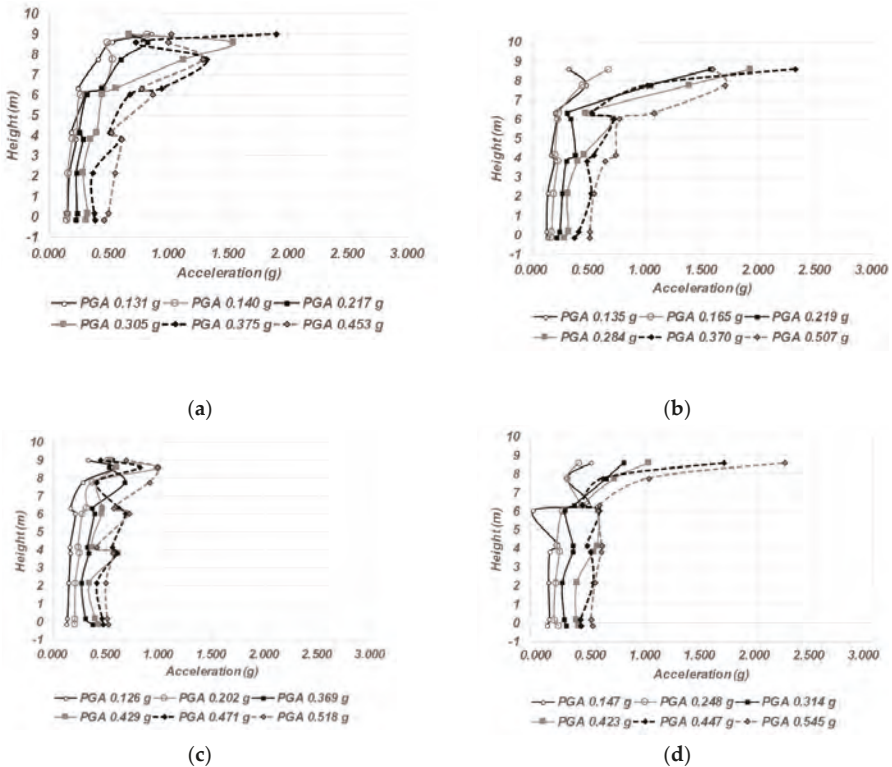
**Figure 6.** Peak acceleration values measured at various heights in the two Cheomseongdae models: (a) Ofunato earthquake motion in original model; (b) Ofunato earthquake motion in Cheomseongdae model without headstones; (c) Gyeongju Earthquake motion in original model; and (d) Gyeongju Earthquake motion in Cheomseongdae model without headstones.

The findings of the dynamic centrifuge tests for the Cheomseongdae models using actual Gyeongju Earthquake motion were (1) the different acceleration values with height in the upper part depending on the absence or presence of headstones; (2) the observation of movement of headstone members similar to that reported after the actual 2016 Gyeongju Earthquake; and (3) a broken stone beam in the 19th layer during dynamic centrifuge tests. These findings show that it is not a coincidence that Cheomseongdae, a masonry structure composed of nearly 400 stone members, survived numerous seismic events for over 1300 years. The structural characteristics of Cheomseongdae, such as the well-compacted filler materials in its lower part, the rough inside wall in contrast to the smooth exterior, intersecting stone beams and interlocking headstones, were shown to contribute to its overall seismic performance based on the results of dynamic centrifuge model testing. It is interesting that Cheomseongdae maintained its original form given the ground conditions since the seventh century. It is a great cultural heritage in which we can still feel our ancestors' breaths and rediscover their outstanding seismic design technology.

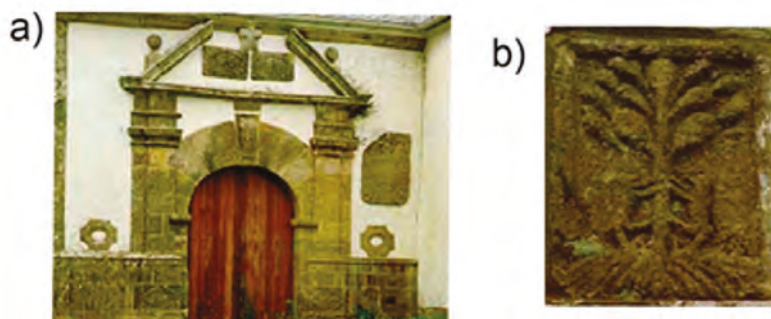
**Figure 4.** Details of the use of the carbonated serpentinite (Pedra de Toelo or Pedra de Moeche) in the architectural heritage of Galicia. This stone can be found in monuments and historical buildings from the Middle Ages. (a) Door lintels, and other architectonic ornaments in the façade of Labacengos church, in Moeche (16th century); (b) coat of arms of the Monastery of Oseira (oso means bear in Spanish).

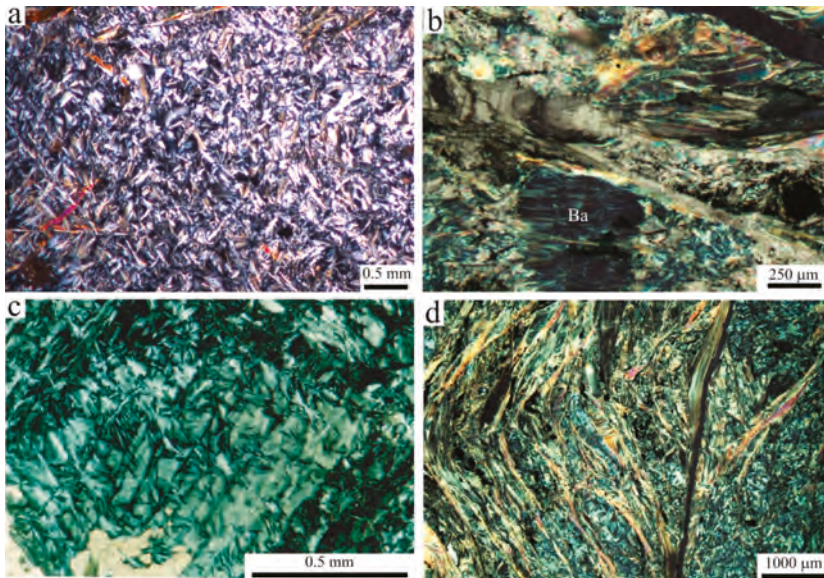
**Figure 5.** Textures found in the Moeche serpentinites (Crossed Nichols): (a) Mesh texture (M-8c); (b) bastite (Ba) (M-3b); (c) thorn texture beginning to recrystallize on bastite (M-2d); (d) fibrous serpentine (possibly chrysotile) (M-10a).

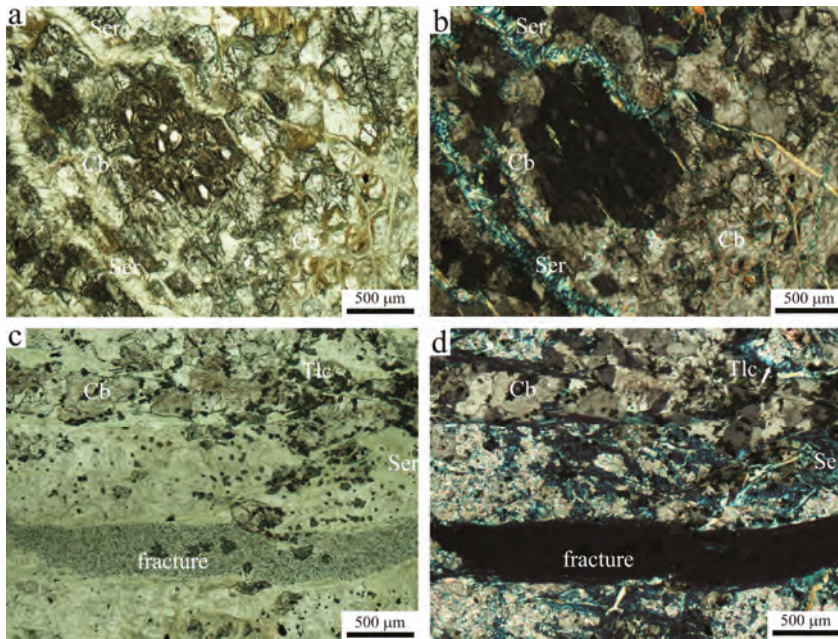
**Figure 6.** (a,b) Sample M-4a. Carbonation of olivine in an early stage of serpentinization with serpentine with mesh texture (a, Parallel Nichols and b, Crossed Nichols); (c,d) sample M-3a showing clean carbonates filling fractures, fracture with predominant talc and carbonate crystals aligned following the foliation and parallel to the fracture (c, Parallel Nichols and d, Crossed Nichols). Ser: Serpentine; Cb: Carbonates; Tlc: Talc.

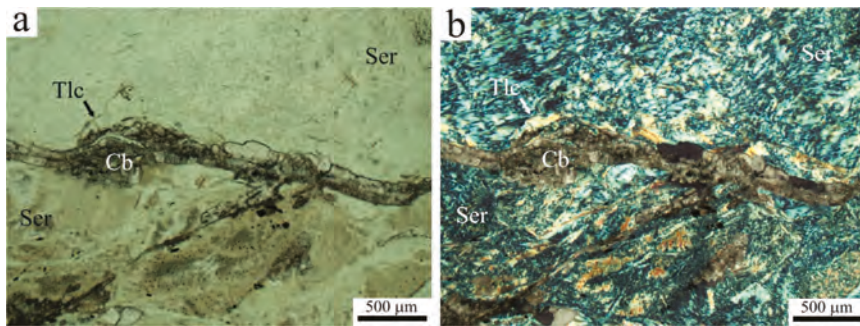
**Figure 7.** The microscopic aspect of a nodulous sample, not foliated, with serpentine minerals, talc and carbonates, the latter filling a fracture. (a) Parallel Nichols and (b) Crossed Nichols. Sample M-2d. Ser: Serpentine; Cb: Carbonates; Tlc: Talc.

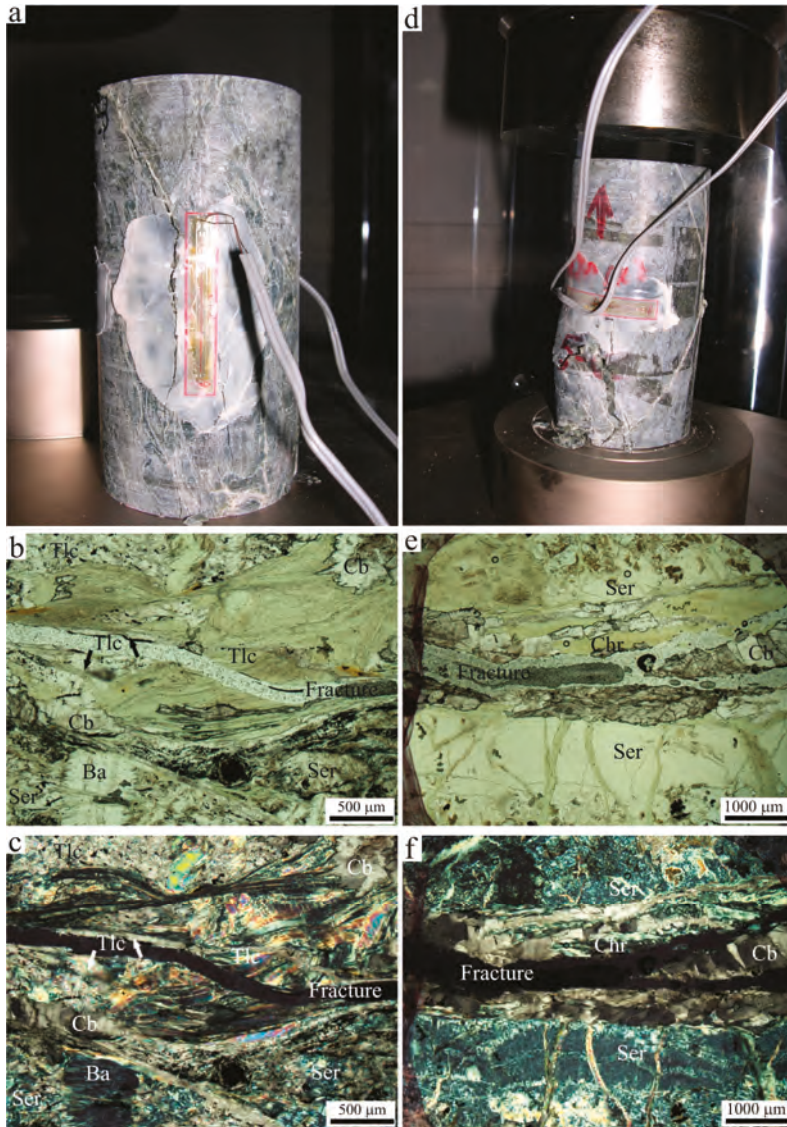
**Figure 8.** Fractured weak rock samples. Left (a–c): Sample M-3b (UCS = 24 MPa), with the failure surface following foliation with abundant talc in the surrounding areas. Apparently, the fracture does not pass through the most carbonated zones. (a) Sample after UCS testing; (b) Parallel Nichols, and (c) Crossed Nichols. Right (d–f): Sample M-5c (UCS = 25 MPa), with the failure surface following an undulated foliation defined by chrysotile and replacement carbonate in relict olivine where serpentinization has taken place. (d) Sample after UCS testing, (e) Parallel Nichols, and (f) Crossed Nichols. Ser: Serpentine; Cb: Carbonates; Tlc: Talc; Chr: Chrysotile.

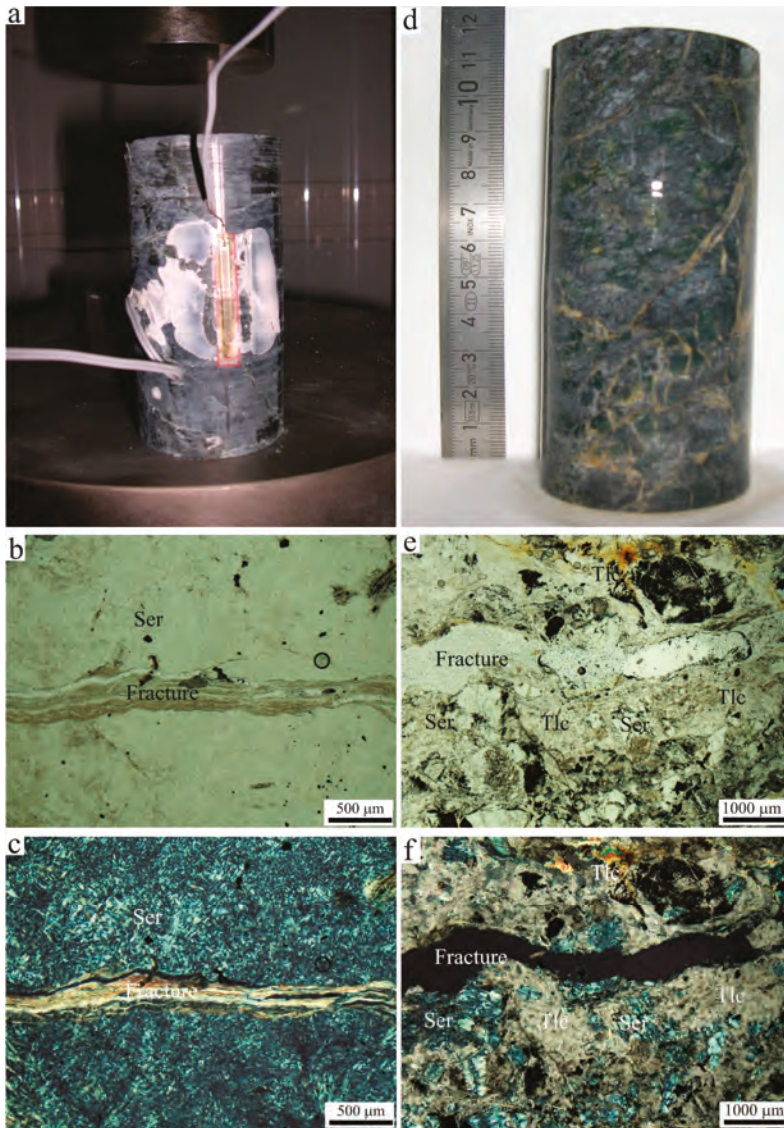
**Figure 9.** Fractured medium-strong rock samples. Left (a–c): Sample M-10a (UCS = 35.1 MPa) with the failure following the serpentinite foliation in a specimen with few previous fractures. (a) Sample after UCS testing; (b) Parallel Nichols, and (c) Crossed Nichols. Right (d–f): Sample M-8d (UCS = 35.8 MPa) with the fracture following the foliation, defined by intense carbonation and relevant talc contents; (d) Sample before testing; (e) Parallel Nichols, and (f) Crossed Nichols. Ser: Serpentine; Tlc: Talc.

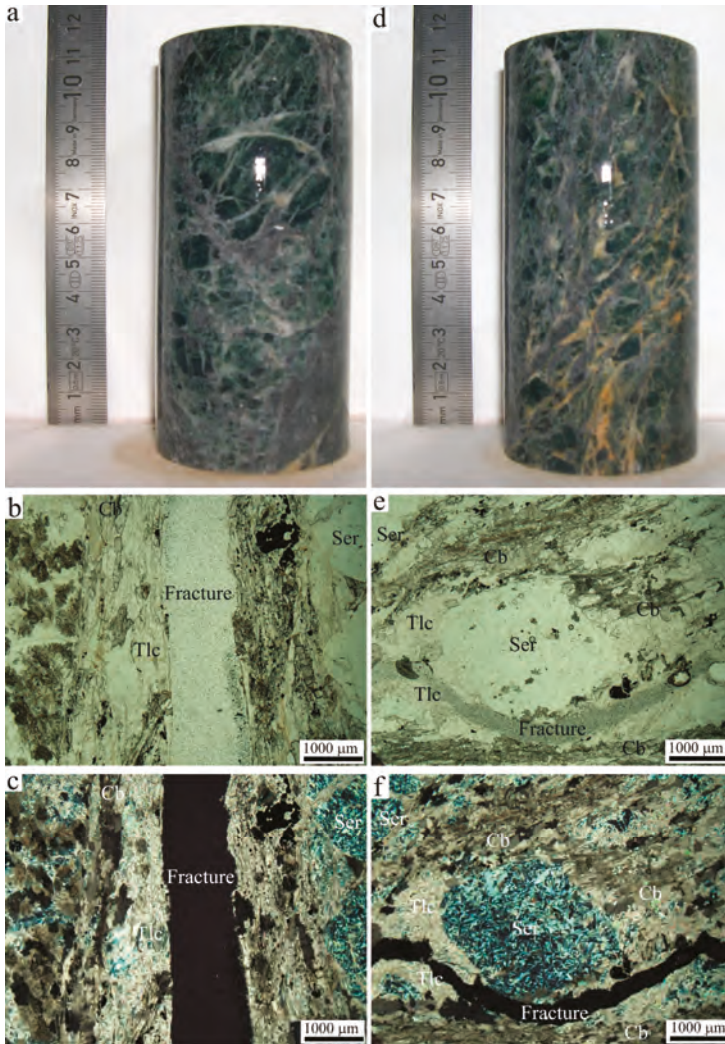
**Figure 10.** Fractured strong rock. Left (a–c): Sample M-7a1 (UCS = 52.2 MPa) showing the fracture following the foliation defined by talc and carbonates. (a) Sample before testing; (b) Parallel Nichols and (c) Crossed Nichols. Right (d–f): Sample M-7c2 (UCS = 70 MPa), with the failure surface surrounding a serpentinized nodule with talc and carbonates. (d) Sample before testing; (e) Parallel Nichols, and (f) Crossed Nichols. Ser: Serpentine; Cb: Carbonates; Tlc: Talc.

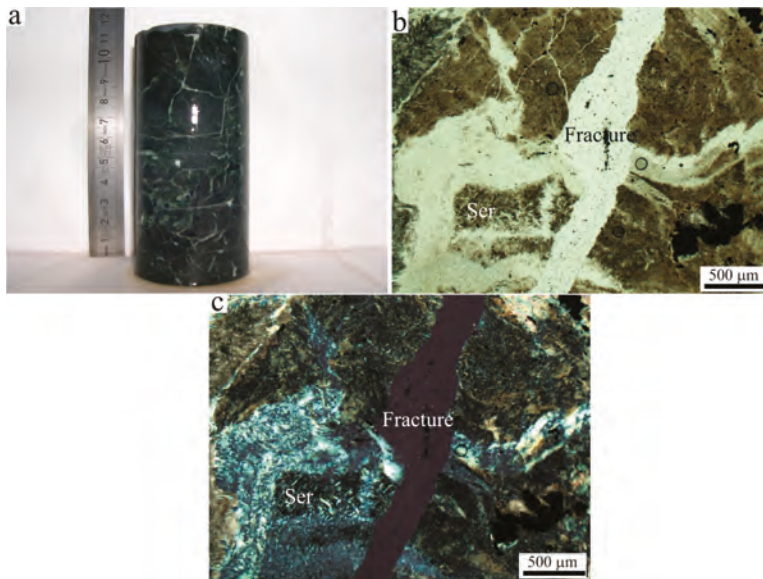
**Figure 11.** The fractured very strong rock sample. Sample M-2d (UCS = 119.6 MPa). The failure surface does not follow previous discontinuities. (a) Sample before testing, (b) Parallel Nichols, and (c) Crossed Nichols are shown. Ser: Serpentine.

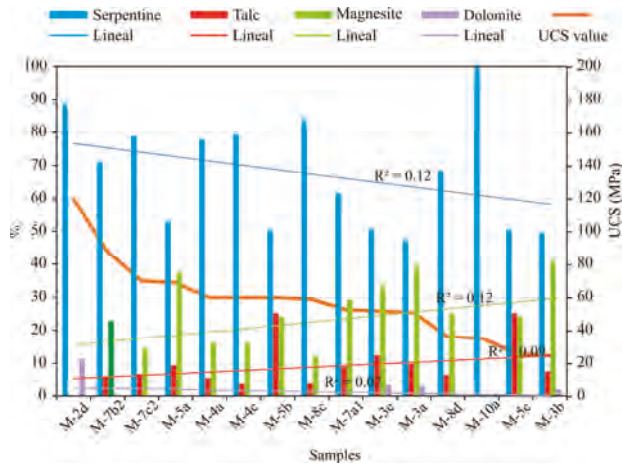
**Figure 12.** Mineralogy of the Moeche serpentinites according to the semiquantitative results obtained in the XRD analyses. Samples are organized from left to right according to their UCS (MPa). Straight lines represent the linear correlation between each mineral and its UCS.

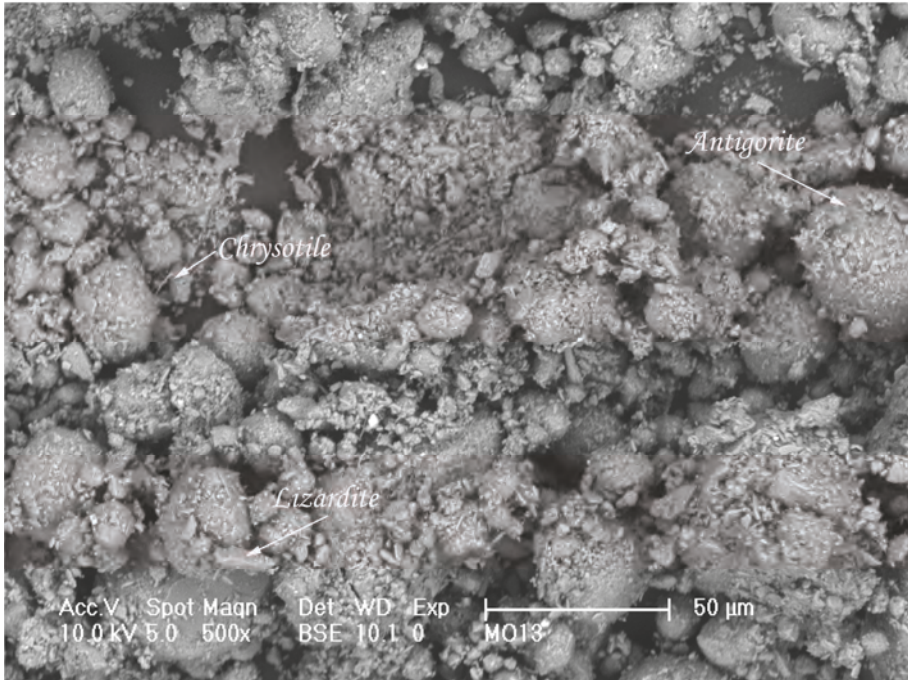
**Figure 15.** Scanning electron micrograph of a serpentinite sample from Moeche. There are predominant globular morphologies identified as antigorite, which is in agreement with the x-ray diffraction analysis. The few prismatic shapes correspond to lizardite crystals, and also a few particles with acicular shapes observed in the micrographs are assigned to the chrysotile phase of the serpentine [55].

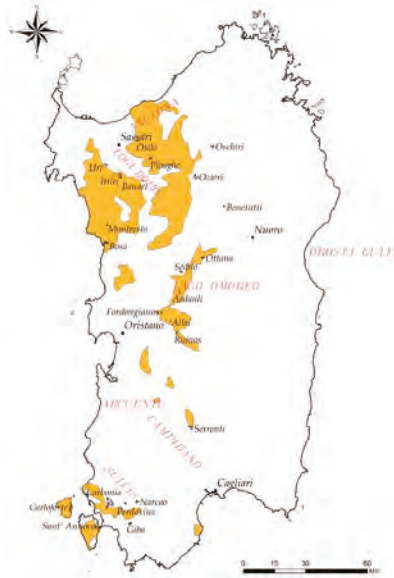
**Figure 1.** Lithological map of Oligo-miocenic volcanite outcrops and localities mentioned in the text (elaborated by Authors from [2]).

Differently, “Trachite auctorum” is the latin term which, in the past, indicated a multiplicity of vulcanites, from acidic to neutral (rhyolites, riocaciti, dacites and andesites), found in Central and North-Central Sardinia (Ottana, Sedilo, Allai, Fordongianus, Bosa, Ozieri, Oschiri and Osilo), southern (Serrenti) and southwestern (Sulcis) as shown in Figure 1. This term is still in use in the

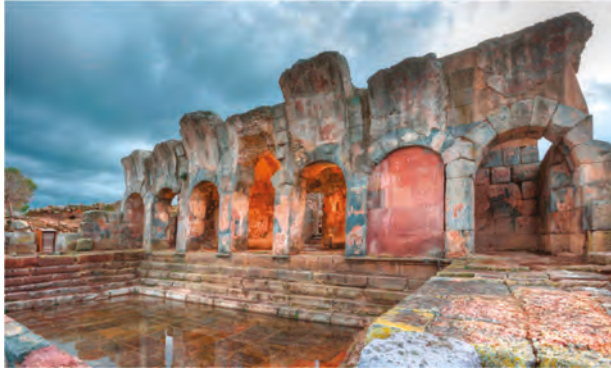
**Figure 2.** Forum Traiani, Ancient Roman thermal baths in Fordongianus (I–III centuries a.c.).

These rocks have been widely used since ancient times, and can be found in numerous constructions located throughout the island. A great use of it was done during the Roman age: For example, the ancient thermal baths of Fordongianus, shown in Figure 2, which were built with squared grey boulders of “trachyte” [7], as well as the seven-arches bridge over the river Tirso, which was built with “trachyte” on top of an older bridge; Sardinian “trachyte” was also used by the Romans for the composition of

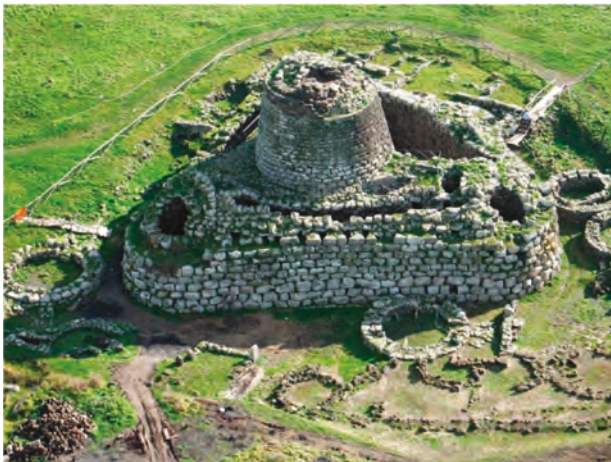
**Figure 3.** Santu Antine nuraghe, near Torralba (North-West Sardinia). It was built from 1800 to 1450 b.c.

mosaics and flooring in Nora. There is extensive footage of ancient “trachyte”, used in prehistory to build defensive walls building, “Domus de Janas” (i.e., fairies’ house), stone huts, nuraghi (i.e., Santu Antine, shown in Figure 3, which is one of the biggest and best preserved nuragic settlements of the island), carved vases (currently exhibited at the local Sardinian museums), mostly dating back to what is generally referred to as the “cultura di Ozieri” (middle Neolithic), etc.

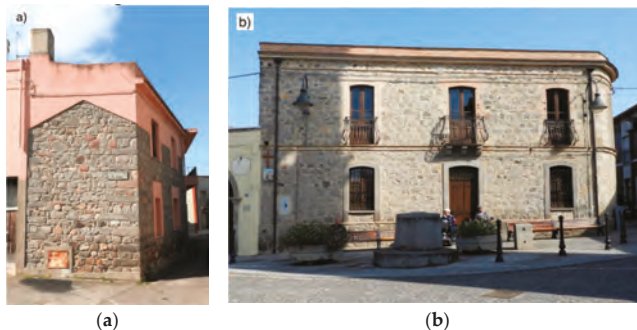
**Figure 5.** (a) and (b): two examples of houses, (a) and (b), built by using “Pietra di Serrenti”.

With regard to the latter, which is currently being reassessed, it is quarried to obtain the stone known as “Pietra di Serrenti”, a light-grey pyroclastic andesite, which is easy to be carved and split; it has been quarried and processed by skilled stonemasons since the 19th century from the quarry of Monte Atzorcu and used to build the traditional portals of both Serrenti houses including the houses (Figure 5), the old market hall and the local Court of Justice in Cagliari (shown in Figure 6), a part of the portico of Via Roma, the churches of San Francesco (in Cagliari, too), squares, and an array of monuments all over Campidano, etc.

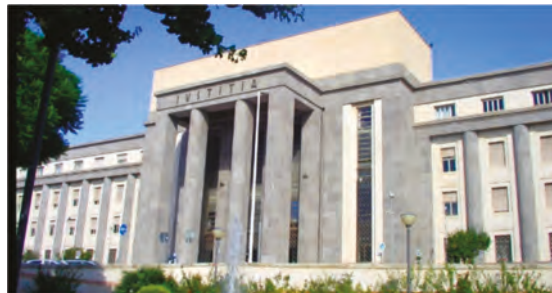
**Figure 6.** Court of Justice in Cagliari, built in 1938 by using also the “Pietra di Serrenti”.

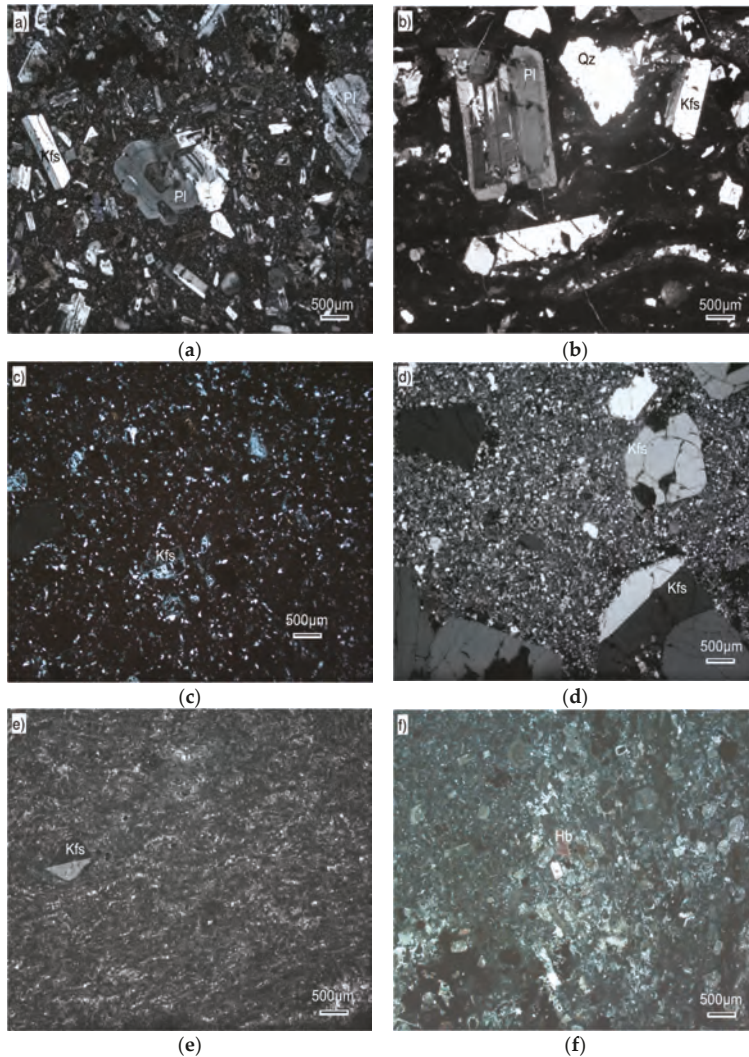
**Figure 8.** Thin section micro-photographies for some representative samples of Early Miocene volcanic rocks from Sardinia. The observed mineral phases are euhedral to subhedral K feldspar, plagioclase, quartz, hornblende in a groundmass from hypohyaline (Ploaghe (a), Sant’Antioco (b)) to hypocrySTALLINE (Fordongianus red (c), Carloforte (d), Allai (e)) showing a porphyritic texture and different porphyric index. In the Serrenti area, the andesitic rocks, which include domes and volcanoclastic products, is interested by epithermal phenomena, so the outcrops are interested by propylitic alteration and silicification (f). Legend: pl = plagioclase; Kfs = alkali feldspar: sanidine; qz = quartz, hb = hornblende.

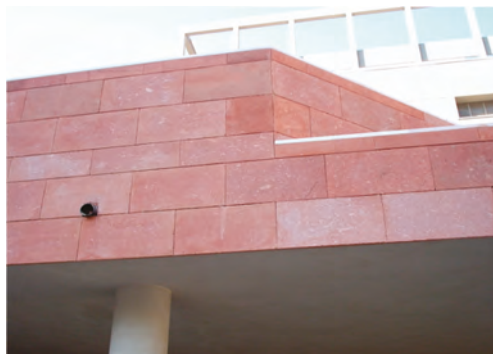
**Figure 10.** A detail of Teatro Massimo in Cagliari; the cladding, installed following a “run” pattern with runs in variable heights, was built using Fordongianus red “trachyte” (renewed in 2009).

The use of “trachyte” has its roots in ancient times, when it was used to make external paving, which has coupled to the use of cladding in contemporary times (as shown in Figure 10).

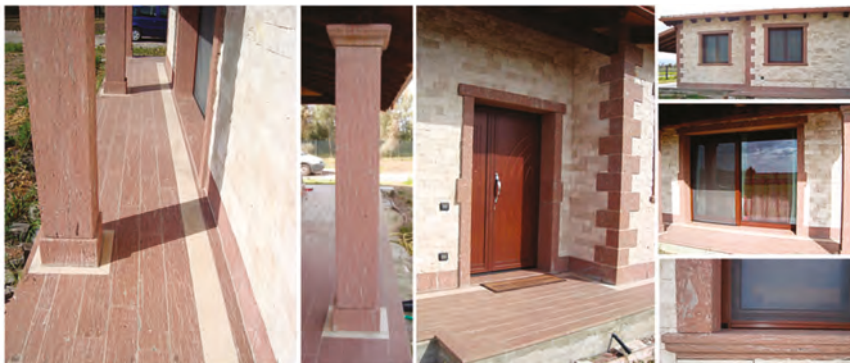
**Figure 12.** Some examples from a private building showing a combination of Red Montresta “trachyte” with Orosei marble (courtesy of Marmi & Pietre I.C.S. s.r.l. [15]).

Sardinian “trachytes” are also used in a wide range of architectural components as arches, jambs, columns, pillars (Figure 12).

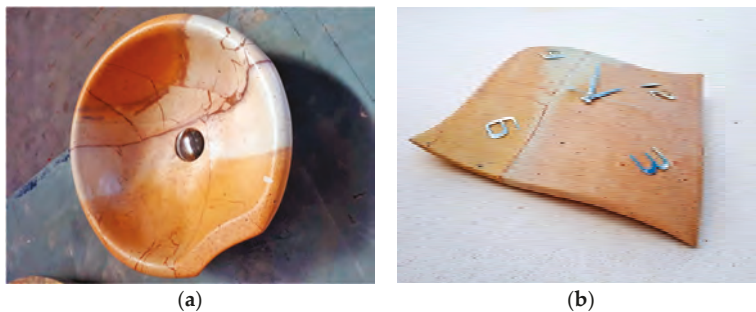
Figure 16. Sink (a) and clock (b) in Ozieri “trachyte” (courtesy of Pedra Noa di Gavino Mulas [19]).

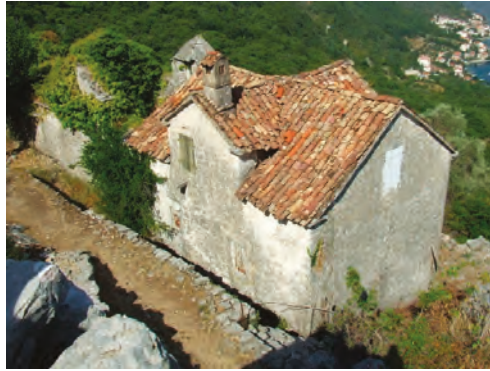
In this area, there is an abundance of limestone, thus dictating the shape of the house and garden. Over three-quarters of construction objects in Montenegro were built using limestone, which was processed by following a centuries-old tradition. Less regularly shaped blocks were obtained by splitting the rocks. This was done manually. The houses were made of fine and rough carved gray limestone, brought from local quarries.

**Figure 3.** Houses in Gornji Stoliv face both the slope and the sea (Photo: Dušan Tomanović).

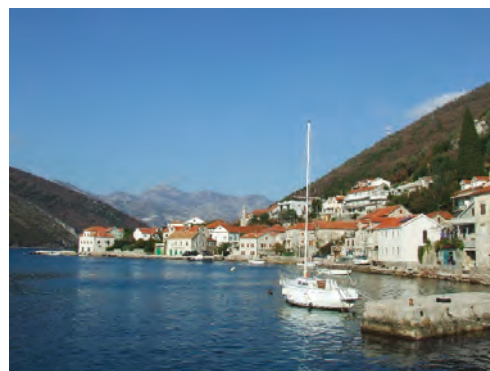
**Figure 5.** Lepetani—a row of stone houses located along the coastal road (Photo: Dušan Tomanović).

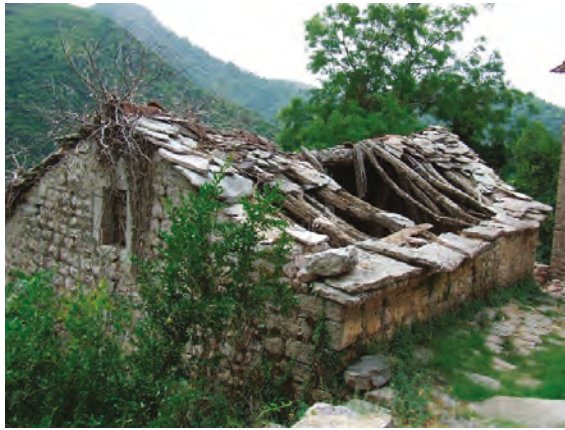
Figure 7. The single-storey stone house is at the core of rural architecture in this part of the Adriatic coast (Photo: Dušan Tomanović).

There are no primal house types proven as old in the rural area of Kotor Bay. Archival materials do not provide any information on the shape of old rural houses, thus we cannot say with certainty what the oldest types of houses looked like. The single-storey house is at the core of rural architecture of this part of the Adriatic coast because of its shape, construction and organisation, since the arrival of the Slavs to this region until today (Figure 7). It is the primary cell from which today's rural architecture has developed [10].

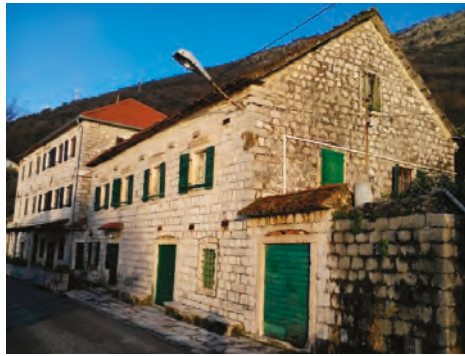
**Figure 12.** Typical seaside house with an upper floor and inhabited loft (Photo: Dušan Tomanović).

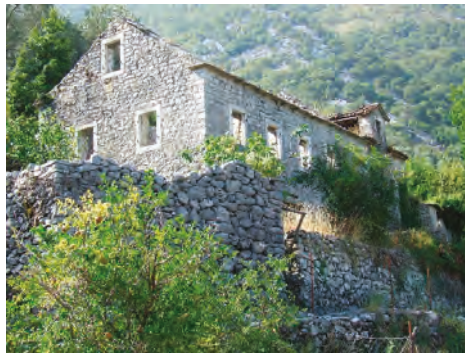
**Figure 13.** Typical multiple-storey house with an upper floor and inhabited loft in upper villages (Photo: Dušan Tomanović).

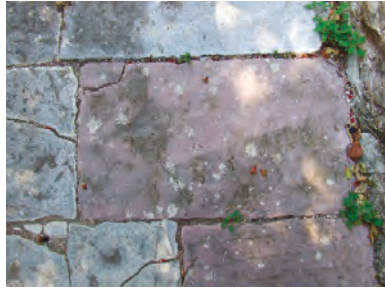
**Figure 14.** Verige and Kamenare quarries contain gray and red plate stones (Photo: Dušan Tomanović).

This region contains a lot of high-quality limestone. The Verige and Kamenare quarries contain plate stone, which was used then but also today for paving the floors of taverns, courtyards, city

squares, and other public spaces (Figure 14). Straight blocks of limestone extracted in Strp and Lipci close to Morinj were used for facades on the houses (Figures 15 and 16).

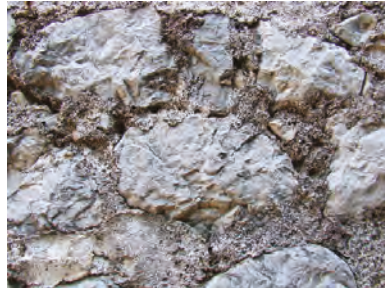
**Figure 15.** Less regular shaped blocks on the lateral façade from Strp and Lipci quarries (Photo: Dušan Tomanović).

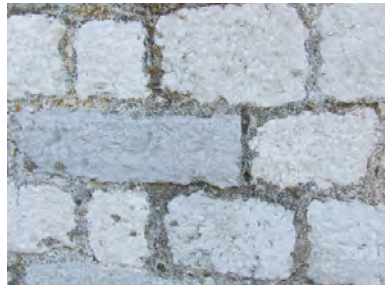
**Figure 16.** Front façade walls were built using the highly regarded fine stone from Strp and Lipci quarries (Photo: Dušan Tomanović).

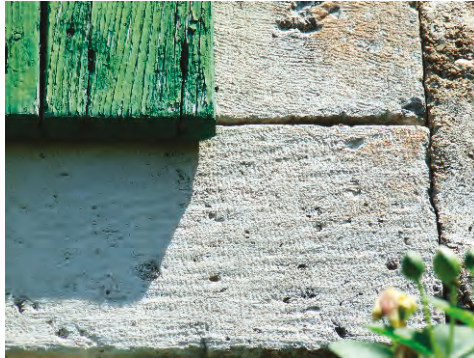
**Figure 17.** The Korčula stone is soft and easy to process; however, due to its lightness and brittleness, it is rarely used for construction, but only for decorating the facade (Photo: Dušan Tomanović).

All sculptural elements were made of stone. They were prefabricated in local quarries or in those on the Brač and Korčula islands (Figure 17). By this, we are primarily referring to heavy house balconies borne by stone brackets (*regula*), frames around the windows and doors, small stone brackets underneath the cornices, and terrace fences made from stone balusters.

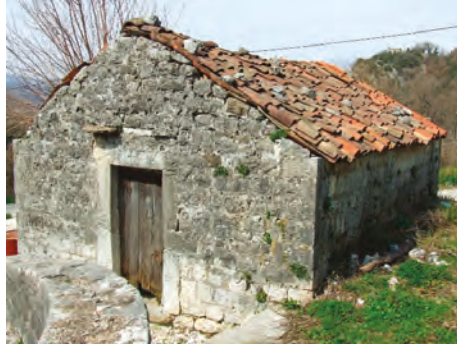
Figure 18. The basis of rectangular houses is most commonly square (Photo: Dušan Tomanović).

These buildings were constructed in a primitive way. The base is square-shaped in most cases. The width and length of the building does not exceed overall dimensions larger than 3–5 m (Figure 18). Local barely regular stones were used for dry construction (with no binding agent). Dry construction (without a binding agent) is the oldest construction technique. It is still used today in the building of stone fences and retaining walls, and was being applied in traditional construction until almost the end of the 20th century.

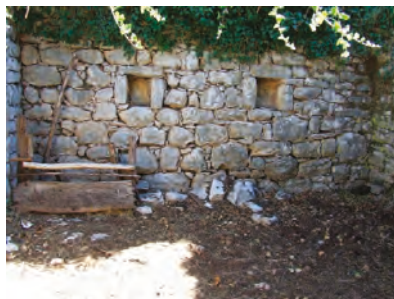
Figure 20. When present, the windows are narrow (Photo: Dušan Tomanović).

There were no windows on these houses in the beginning. Later, in the 19th century, windows were small in size, if existent at all, and faced the slope down towards the field and the sea (Figure 20). Windows got larger with time, so their size was about 1 m by the middle of the 20th century [13].

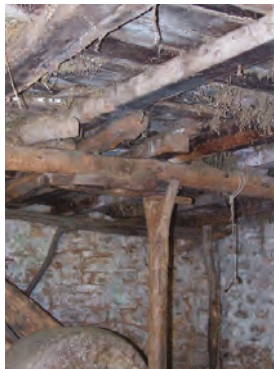
**Figure 21.** Roof construction is supported by a wooden forked pole (Photo: Dušan Tomanović).

The roof construction of these houses is very simple. It consisted of a single ridge beam stretching from the middle of one tympanum until the middle of the other one, supported by a forked pole named “soha” by the locals (Figure 21). Brotches do not lean on the ridge beam, but are simply joined at the ridge, digging into the wall at the position of the pole plate. Laths made of carved branches are thrown over the brotches and later covered with flagstones (before that, in the 18th and 19th centuries, thatch, bulrush or wooden slats and the like were used). As the brotches leaned on the inner side of the wall, the roof is slightly curved upwards at the end.

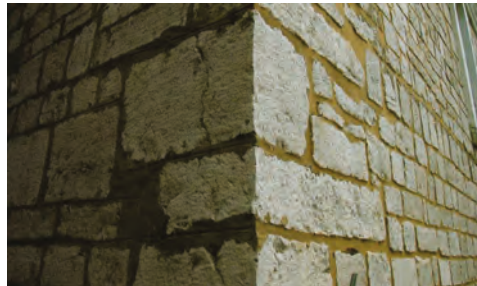
Figure 23. The corners of the house were made using blocks of greater length (Photo: Dušan Tomanović).

One large stone was used to connect both sides of the walls at every 2–3 m interchangeably in each row, thus fitting two walls together. This stone and procedure were called “wall binding” by stonemasons. In the corners of the house, we can see corner blocks (Figure 23). They were somewhat larger in size, more regularly processed, their colour was a darker grey, and the stability of the stone house partially depended on them. The longitudinal walls of the house were finished with wreath made of stone slabs (kotali). Gable walls are also made of stone slabs measuring 10 cm.

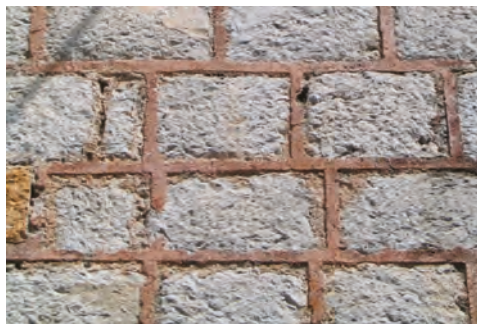
Figure 25. An example of a joint protruding out of the wall lines (Photo: Dušan Tomanović).

Joints are usually filled with mortar along the wall lines and their size varies from 5 to 7 mm. Joint processing is not always the same everywhere. Those house owners who did not find their joints along the wall beautiful or efficient enough processed them in a different way: the joints were filled up until the wall line, and subsequently the horizontal and vertical ones, protruding out of the wall lines by 3–5 mm with completely straight and sharp edges (Figures 24 and 25).

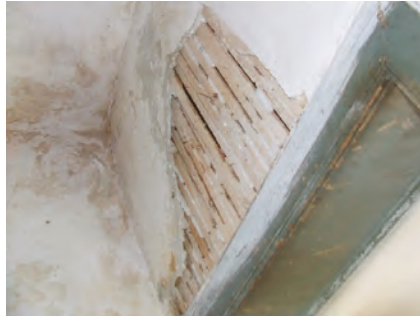
Figure 26. Dividing walls are made of wood and later plastered (Photo: Dušan Tomanović).

In most houses in the Bay of Kotor area, dividing walls are made of wood, then plastered later (Figure 26). When property was to be partitioned, houses got divided by walls vertically, and not by floor. Dividing walls were most commonly built by vertically setting 3 cm thick planks, uneven in size, which varies between 5 and 10 cm (Figure 27). Horizontally nailed slats 3 × 3 cm in size were placed on both sides of the planks at a distance of 2–3 cm. Pre-cut planks were often used instead of slats, on the same distances. After all of this comes a 1 cm layer of lime (or later cement) mortar used to fill all cavities. The thickness of such dividing walls varies between 9 and 12 cm.

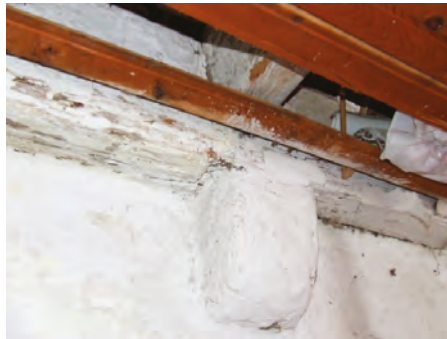
**Figure 28.** The small bracket carries the floor joist beam on the inner side of the wall (Photo: Dušan Tomanović).

- On stone teeth (Figure 28)
- On the wooden beam placed on the wall
- Inside previously prepared holes in the walls (built-in) (Figure 29).

Tooths are stone brackets, sometimes made of local stone (most commonly in upper villages), sometimes of Korčula stone (on the sea), and protrude 16 cm from the wall and are 13 cm in height. They are housed in the massive outer 20–25 cm wall.

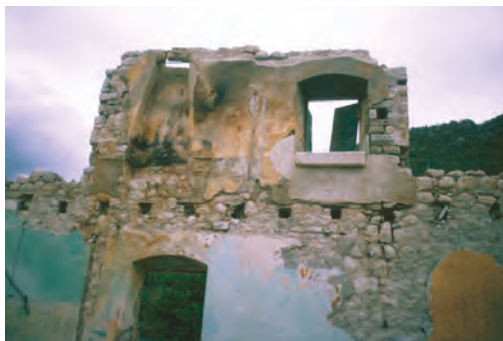
**Figure 29.** The floor joist beams are put into previously prepared holes in massive stone walls (Photo: Dušan Tomanović).

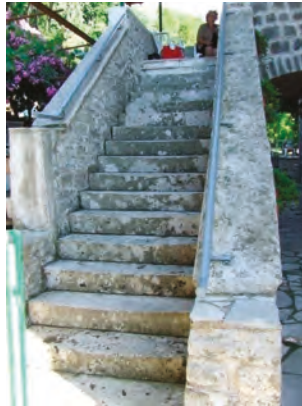
**Figure 30.** The tread and fence of the external stairway are mostly made of stone (Photo: Dušan Tomanović).

The stairway and its elements—the tread and the front are usually made out of flagstone. The treads are uneven in size: 28 to 30 cm, while the height of the front is stable (12 + 3 = 15) or 13 + 2 = 15 cm.

The fence of this staircase is stone-made, which is almost always the case. Balusters are placed in some places, while others prefer to have their fence made from wrought iron. The stone fence is 80 to 85 cm in height, the wrought iron one is 85 + 5 for wood, while balusters come in different heights and shapes, and they are also stone-made (Figure 30).

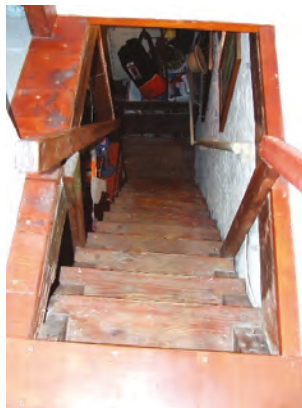
**Figure 31.** The interior stairs are always made of wood (Photo: Dušan Tomanović).

At the beginning of the 20th century, the interior stairways were made of wood (Figure 31). They led upstairs, towards the *inglo*, and to the ground floor towards the *konoba*. Rev. Nakićenović describes them at the beginning of the 20th century: “The stairs reach the first floor in all houses, if they are in the house they are usually made of stone, while those that come from the yard, which is in Luštica usually stone-made. On the second floor they are made exclusively out of stone. Both are spacious and nicely laid, that is to say, easy to climb. Divided houses are an exception, and there, stairs would be narrow and steep because of a lack of space [20].”

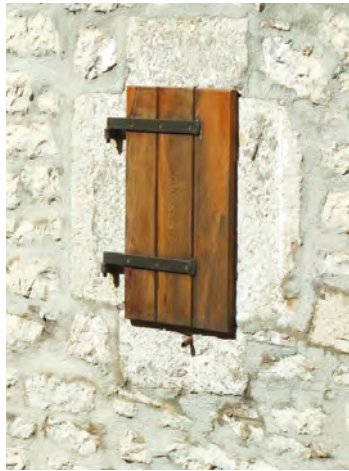
**Figure 32.** Openings were small on single-storey houses (Photo: Dušan Tomanović).

Single-storey houses sported windows that were small or non-existent (Figure 32). Their shape and proportions are typical for the stone architecture of the seaside in general. During the 20th century, they became somewhat larger—about 1 m.

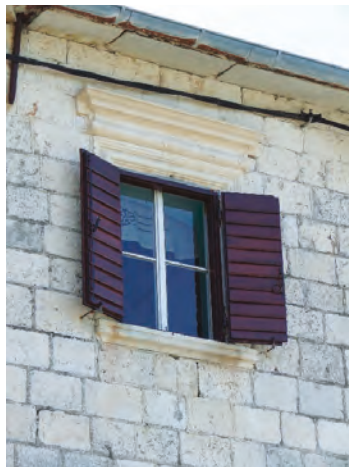
**Figure 33.** Windows on multiple-storey houses were defined by the quality of the window frame (Photo: Dušan Tomanović).

Larger windows appear on multiple-storey houses. Window size and proportions of the window opening were also defined by the quality of the window frame (imported or local) (Figure 33).

Window frames were usually made of better quality stone, which was also better processed. Holes were dug in stone frames, on the inside, to accommodate the wings later. The span of the lintel beam is slightly larger than the breadth of human shoulders. They are somewhat higher, in order to get rectangular openings of the aspect ratio 1:1.4, which are close to  $1:\sqrt{2}$ .

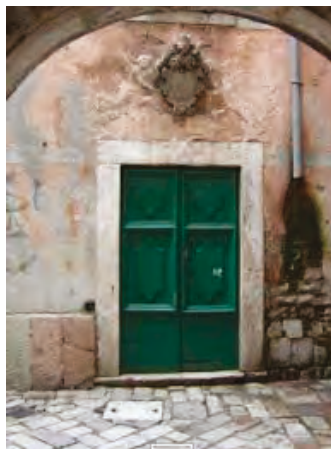
**Figure 34.** A door with no fanlights is framed with rectangular stone frames (Photo: Dušan Tomanović).

These doors have no fanlights, and they open to the inside. They are either enclosed in a better processed local flagstone or in frames made of Korčula stone  $\frac{1}{2}$  of a Venetian foot in width, which is 17 cm. Lintels are positioned above the door, and there often is a relieving arch on top (Figure 34).

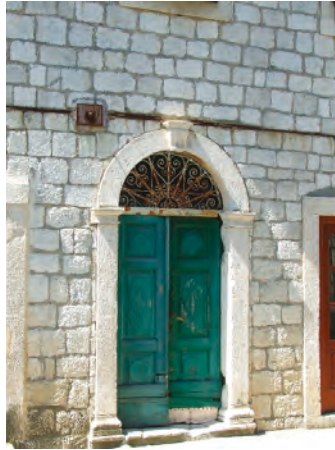
**Figure 35.** A door that does have fanlights is framed with arched stone frames (Photo: Dušan Tomanović).

single-winged, later developing into double-winged doors. In arch doors, we can see a separate semi-circular part above the wings, but the wings themselves sometimes end up with an arched shape. They were manufactured using wood, and mostly coloured in green and white (Figure 35).

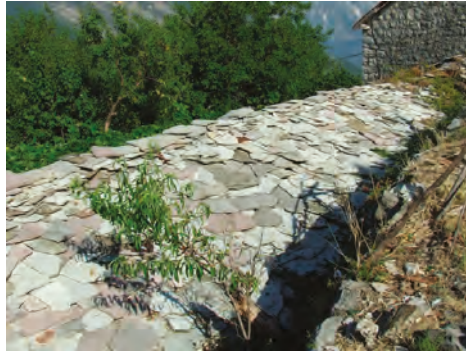
Figure 38. Flagstone roofs were dominant in the 19th century—Veće brdo (Photo: Dušan Tomanović).

Roofs on village houses are mainly double-sloped. Roof slope is anywhere from 28 to 32 degrees. Since the Bay of Kotor is known for its abundant precipitation, the roof protrudes slightly more with flagstone cornices (kotali). In the past, roofs were covered with flagstone blocks, found ubiquitously in the Bay of Kotor area (St. Vid, Verige, Kamenari, Strp) (Figure 38). This can be concluded after revising numerous remains in the upper villages of Prčanj, Stoliv, Veće Brdo, Gornja Lastva, Bogdašići. Before this, roofs were sometimes covered in thatch.

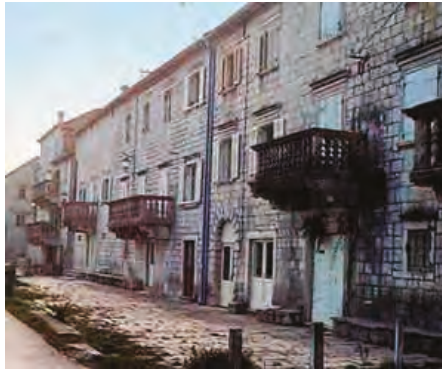
Figure 40. Typical stone balconies on houses in Prčanj (Photo: Dušan Tomanović).

The balconies are not large in size and the question remains if they had a practical use, aside from the purely aesthetic belvedere (nice view) function. The balcony width ranged from 90 to 110 cm, with varying lengths (Figure 40). They are usually placed in the centre of the main façade, while the symmetry in relation to the façade (doors and windows) is strictly respected. All balconies are constructively supported by large stone brackets “regule”, richly stylistically decorated and processed.

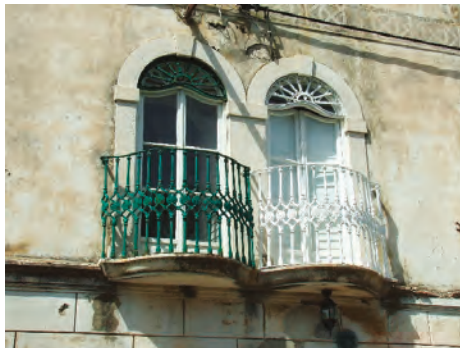
Figure 41. At the beginning of the 20th century, balcony fences were made from wrought iron (Photo: Dušan Tomanović).

In most cases, balconies are surrounded by balustrades of different shapes and heights. Balustrades are surrounded by cornices from the top and the bottom, and its length as well as the length of the entire fence is divided into 2, 3 or 4 fields (depending on the length of the balcony). The fence is about 75 cm high. Later, in the 19th and 20th centuries, on some houses, stone balustrade fences were replaced by wrought iron fences (Figure 41). The upper surface of the balcony (the tread) is not covered and it is exposed to atmospheric conditions. It is coated in flagstone from local quarries. A double-winged door, which is in most cases enclosed in *voltes* (arch-shaped stone frames), leads to the balcony. As a rule, the doors open inwards. Initially made of solid wood, they were later combined with glass. Sometimes, the part where the arch starts and ends is being glazed, while the lower part is made from wood and glass, or solid wood.

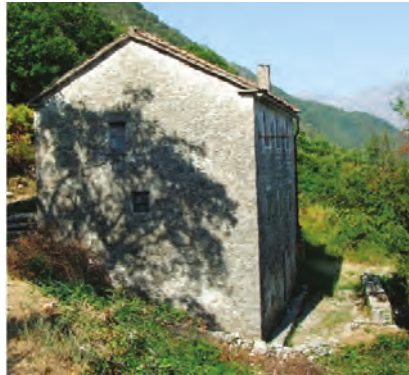
Figure 42. Terrace on the ground floor (Photo: Dušan Tomanović).

Terraces are almost always present in upper villages, and significantly less in the lower parts. Depending on the slope, they are usually located in front of the house at ground floor level or at the first-floor level (Figure 42).

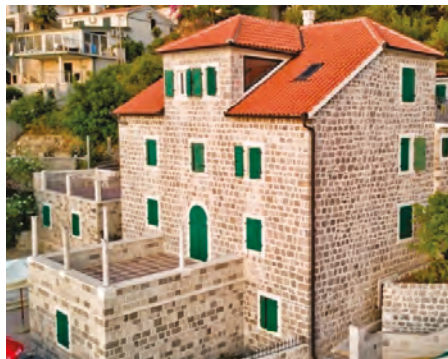
When placed on the first-floor level, a stone *volte* bears its load. The terrace is plate paved with rectangular stones brought from local quarries on both the ground floor and the first floor. It is surrounded by a “*pijuo*”, a stone bench with a seat and a backrest (Figure 43).

Figure 43. Terrace on the first floor (Photo: Dušan Tomanović).

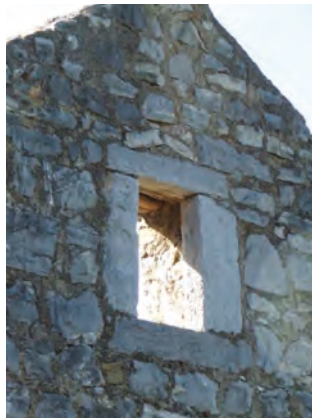
**Figure 44.** Window and door frames in the hinterland are mainly composed of monolithic stone with no stylised cornice (Photo: Dušan Tomanović).

- a. With enclosures, i.e. "frames" made of local stone (Figure 44)
- b. With frames made of Korčula stones and without stylised lintel cornices
- c. With frames made of Korčula stones and with stylised lintel cornices (Figure 45)

Frame faces were well processed, while inner parts were done more roughly. Stone enclosures around openings (frames) play a constructive role, aside from being aesthetically pleasant. Door openings influence the door shape and determine its dimensions. Such openings could be finished in a straight or arch-shaped way. With straight frames over larger spans, a relieving arch is added to avoid cracking.

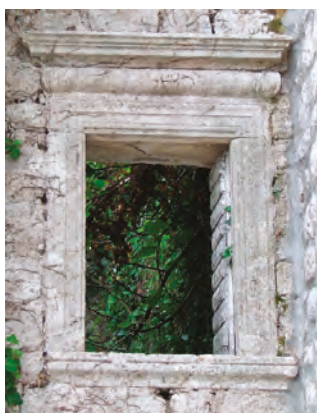
**Figure 45.** Frames made from Korčula stones with stylised cornices (Photo: Dušan Tomanović).

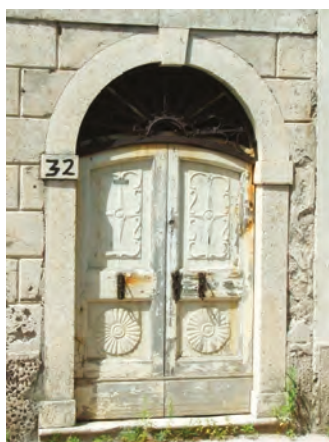
Frames over arch-shaped doors and windows (volates) are somewhat more specific and wide. They are manufactured in two parts, and connected by a decorative bracket with a frieze on top (Figure 46).

**Figure 46.** A stone frame above an arch-shaped door, connected by a decorative bracket at the top (Photo: Dušan Tomanović).
