# Natural Stone and Architectural Heritage

Edited by  
Lola Pereira, Lidia Catarino and Giovanna Antonella Dino  
Printed Edition of the Special Issue Published in *Sustainability*

Special Issue Editors

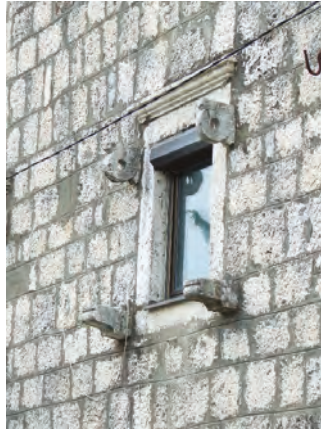
Figure 47. Brackets with a single hole “auriculae” (above) and “dentes” brackets (below).

- brackets with a hole (auriculae) (Figure 47)
- brackets underneath the lower window frame (dentes) (Figure 47)
- brackets bearing heavy stone balconies (regulae) (Figure 48)

Brackets with holes (auriculae) supported the curtains from the outer side and protected the inhabitants of the house from sunlight during the summer. Their dimensions are 30/25 cm and they are placed under the lower line of the upper lintel frame. Their width ranged from 5 to 7 cm. They exist in variations with one and multiple holes.

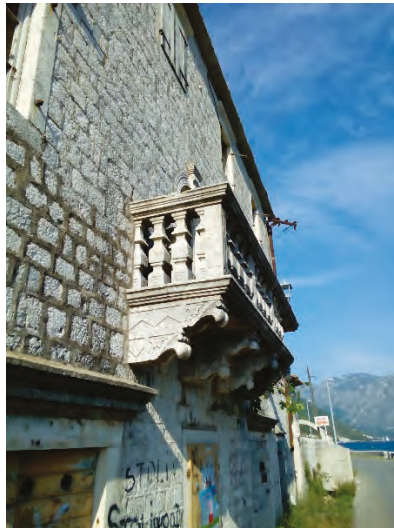
Figure 48. The regulae support heavy balconies (Photo: Dušan Tomanović).

The balconies are not large in size and the question remains if they had a practical use, aside from the purely aesthetic belvedere (nice view) function. The balcony width ranged from 90 to 110 cm, with varying lengths (Figure 40). They are usually placed in the centre of the main façade, while the symmetry in relation to the façade (doors and windows) is strictly respected. All balconies are constructively supported by large stone brackets “regule”, richly stylistically decorated and processed.

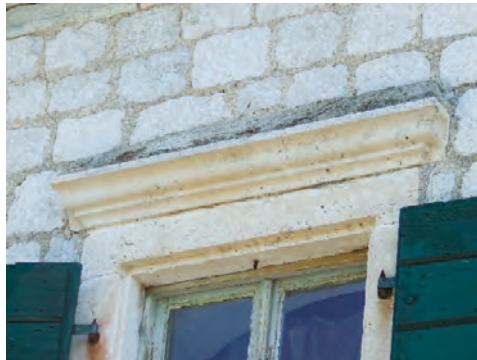
They are placed above the window, the door, or gates (Figure 49). Their dimensions vary and depend on the size of the opening above which they are placed. Stonemasons from Korčula standardised them, and the largest number was bought in their workshops. Their lower part leans on the upper window frame and the door. Aside from the aesthetical function, they had a practical one, which was to prevent rainwater from entering through the openings, since rain would be falling from the roof directly onto the floor.

**Figure 49.** The frieze leans on the upper door and window frame with it's lower part (Photo: Dušan Tomanović).

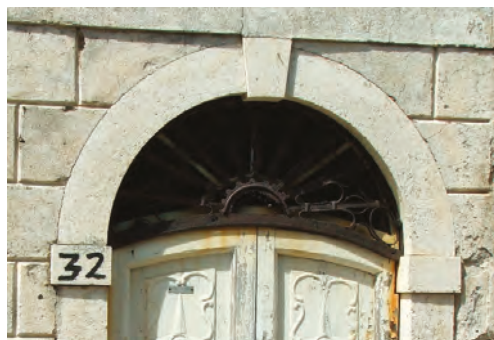
A rich frieze means a rich house owner. Special attention was given to friezes above arch-shaped doors with a small decorative bracket at the top (Figure 50).

**Figure 50.** A frieze above an arch-shaped door with a small decorative bracket at the top (Photo: Dušan Tomanović).

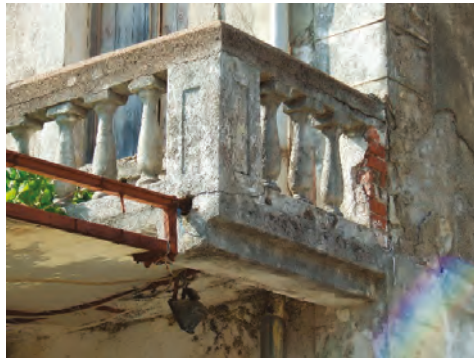
**Figure 51.** Balusters are present on the coast, and absent in upper villages (Photo: Dušan Tomanović).

The appearance of balusters is not consistent with the tradition of folk architecture, but they did announce the gradual formation of the local architecture language and its dialects. Balusters, or stone pillars, are used to fence not only balconies, but inner yards and atria as well. They appear sporadically on the coast, while they are not present in upper villages (Figure 51). This shows us that they started being used in later stages, since all lower settlements were created afterwards. They are most common in the following places: Perast, Orahovac, Mula, Prčanj, Donji Stoliv, Donja Lastva. It was probably sea men who brought balusters from their numerous trips around the world, into the cities at first, around the 17th and 18th centuries (for example, balconies on the 17th-century Gregorina Palace in Kotor or the mid-18th century Dabinović Palace in Dobrota), and later into nearby cities sometime in the second half of the 19th century.

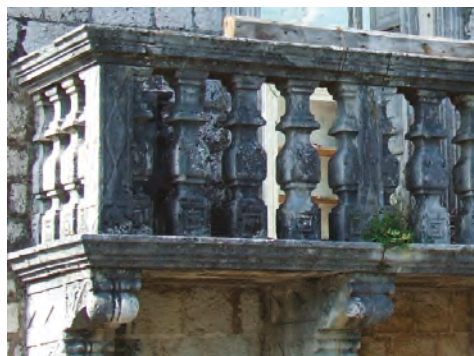
They vary in shape, height and width. Framed with frieze beams and stone pillars, they were manufactured from stone and processed with high precision in this period. The baluster type with three highly convex-concave parts with sharply protruding edges towards the outer borders, with a square base and a decoration made of concentric squares (which differ from the usual baluster division in the shape of a single or double “pear”) is the most common type on the Vrmac (Figure 52). It was also present in earlier architecture in the Bay of Kotor in the 17th and 18th centuries.

**Figure 52.** A type of baluster with three convex-concave parts with sharply protruding edges on the outer borders and with a square base (Photo: Dušan Tomanović).

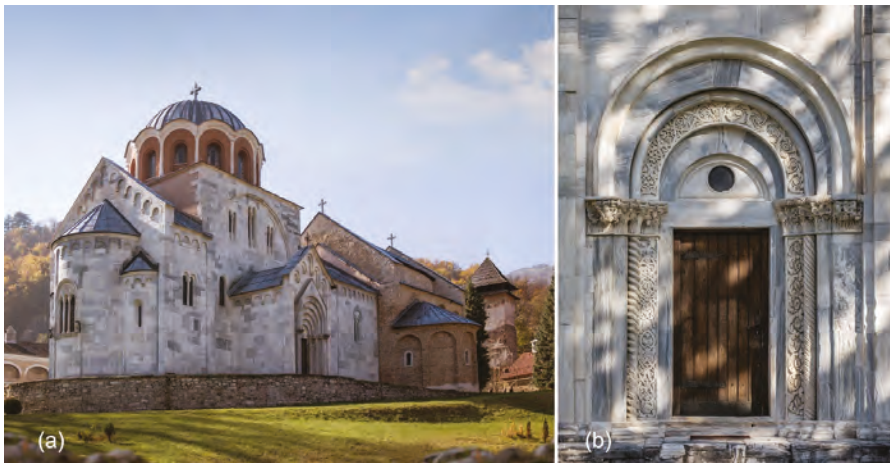
**Figure 4.** (a) The Church of the Holy Virgin 12th century view from the northeastern side. (b) Southern portal © LiveViewStudio.

One of the most significant mediaeval Serbian endowments, the Studenica Monastery and the Virgin's Church (Holy Theotokos), was built by the Great Prince Stefan Nemanja. The church represents the greatest feat of an authentic architectural style called the "Rascia School" [31]. This original piece of architecture came about as a reflection of a specific position and political orientation of the mediaeval Serbian state. By making a synthesis of the two architectural models—one coming from Byzantium and the other from the West—the marble-wrapped Virgin's Church was materialised. The use of the polychromatic marble on the church exterior façades may have been drawn from the extensively applied material in the church architecture of Constantinople [1]. Its "Romanesque" portals and windows are shaped according to an already set geometrical scheme, completed with various figural images, lavish floral ornamentation and interlaced combinations of both (Figure 4).

On the one hand, the entire aesthetic of the church structure is visible in a synchronised materialisation of the portal and the windows, while on the other, the stone carved decorations on certain architectural marble elements were formulated in a variety of ways. There is a special classic feeling in shaping the capitals of the free-standing colonnettes, showing visible differences in the manner and the extent of their construction. On the south portal there is a luxuriously carved frieze made of Corinthian capitals with human heads, whereas the north ones feature only an abacus. It is quite normal for the Romanesque portals to have differently carved capitals that flank the portal, as well as the entire door frame [32].

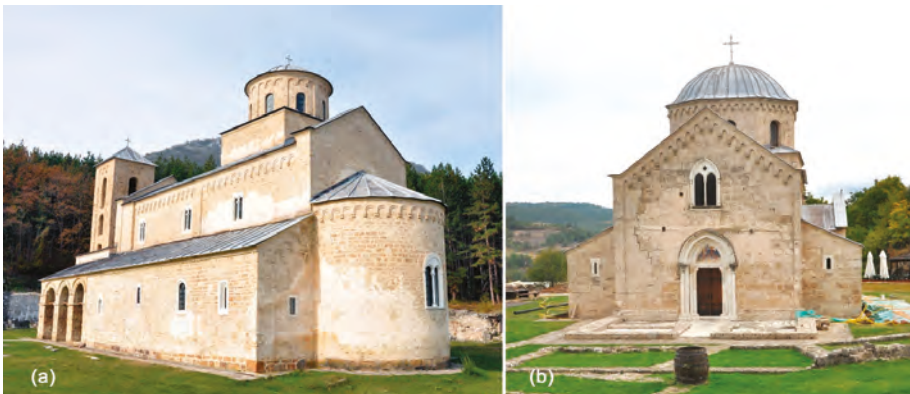
**Figure 5.** (a) Sopocani Monastery 13th century (b) Gradac Monastery 13th century © NDRistić.

The bifora windows feature a variety of carved capitals unevenly decorated but evenly shaped at one and the same workshop. Besides sculptural carvings with the use of chisels and picks in order to generate classical motifs of a stylised Ionian volute with a Romanesque-like leaves or floral pattern on the calathos, here we also have a specific use of drills for making numerous holes in order to free the carvings from the rest of the material, but also for decorative purposes, for creating a sense of inner dark shades. In order to make a better visual impression, the holes were filled with molten lead. Such a way of doing the stone capitals was going to be used as a model for carving capitals on other church structures in the 13th century [33] (Figure 5).

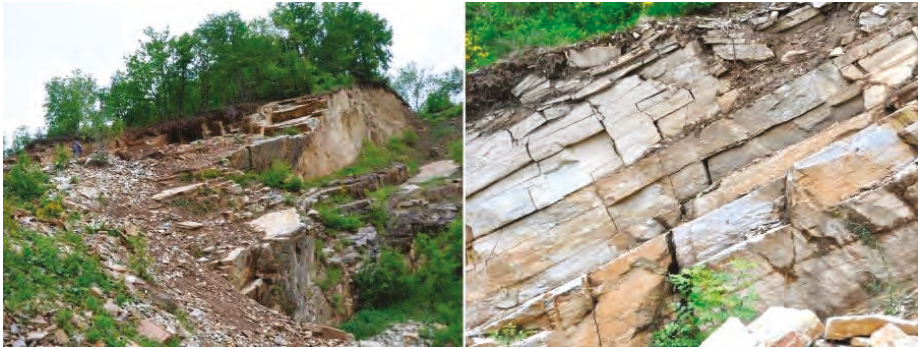
**Figure 7.** Historical Quarry in Vrh (Kotline) © NDRistić.

sites between three villages, today known as Vrh, Dolac and Brezova. In that area, where marble has been quarried until the present day, numerous deposit sites have been identified, which we know have been exploited since the Middle Ages. With time, along the rocky massif, in places that were almost inaccessible, stonecutting settlement communities were formed, which today help us in orienting and locating the marble quarries. Each of the said villages extend to several hamlets—Vrh with its Gobelja hamlet, Dolac with the hamlets of Vranjevo, Backulje and Bozici and Brezova with its hamlets of Godovic and Gusterica (Figure 7).

The Vrh village quarries are situated on the south slopes of Backa Stena, at elevations of 1150 to 1050 m, known as Draskovac. One old Studenica quarry was identified also near Gobelja hamlet, in the place called Kotline. Along the quarry goes the Brevina River gorge formed by the deposits of marble material. Here, the traces of old marble quarrying techniques have been found. Inspecting the rock, the positions of the holes have been observed, where wedges and iron levers were used on the rock to extract large blocks. Also, some old tools have been found such as a massive sledgehammer of about 7 kg with one side shaped into a pick, as well as one plug made of hard solid iron [7].

Strip blocks of blue-grey marble on the Virgin's Church come from this quarry site. Although there are varieties of marble strips in other quarries in the vicinity, these fine types are of very fine grain structure, basically white or blue-grey in colour. The exquisite beauty of the marble is the section where white, unpigmented stone alternates with the pigmented ones, mostly grey to black-grey shades. Horizontal marble strips are of 2 mm to 10 mm thick, quite eye-catching at places or sometimes rather low-key. When looked at closely, it may be observed that within one pigment vein there is a strip-like structure with millimetre thick blue-grey lines of different intensity [7]. Some of the most beautiful are varieties on the church façade with 4 strips at 12 cm. Their depth of extraction could not have been more than 60 cm, which apart from the aesthetic effect, points to a functional choice of this construction variety. In its consistency, it is classified as natural stone easy to carve, cut and polish, which is best manifested in the work done on the Studenica Virgin's Church windows and portals. The marble stripe layers were cut into blocks that were then very carefully, depending on the cutting directions, fitted into the façade walls. Choosing different directions of cutting relative to the stone structure, the builder wanted to accentuate certain church elements. The portals are mostly built of this variety marble blocks, although there are details of carved architectural elements in pure white blocks, like for instance, toned portal columns in the south vestibule. A special dynamism is achieved in vertical pilaster strips cut in blue-grey veined marble, combined with white short columns.

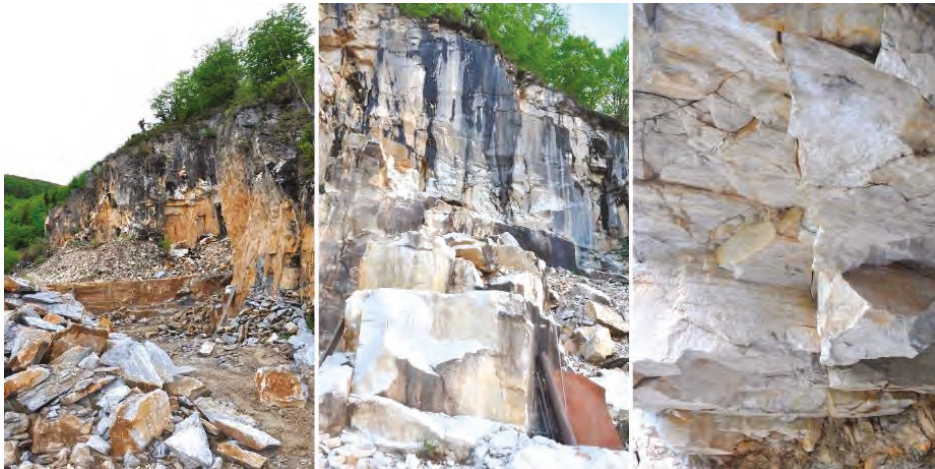
The area and steep cliffs make the sites rather hard to access in modern times, as well as the application of modern stone extraction techniques, save the old ones using picks and hammers. So, until the present day, marble extraction has been done manually. Furthermore, and interestingly, in cutting and polishing processes, no water was ever used, although the area abounds with it (Figure 8).

Figure 8. Historical Quarry in Godović © NDRistić.

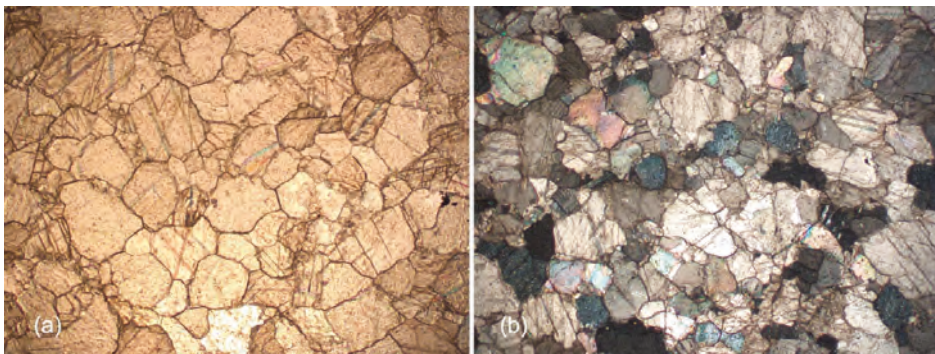
**Figure 10.** Macroscopic structure of sample 1 marble: (a) With parallel nichols (b) With crossed nichols.

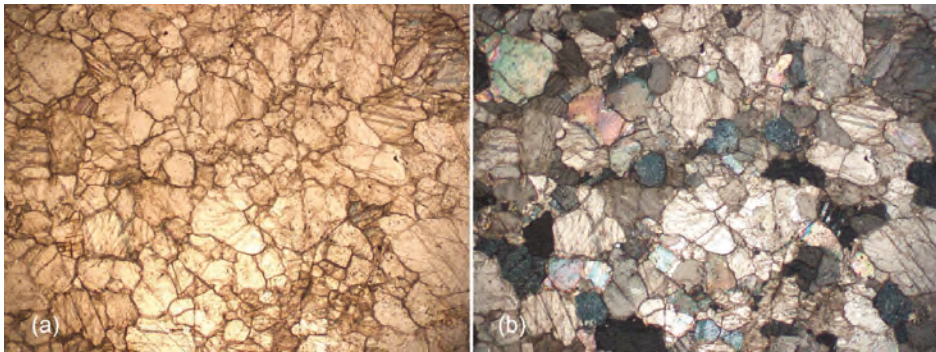
**Figure 11.** Macroscopic structure of sample 2 marble: (a) With parallel nichols (b) With crossed nichols.

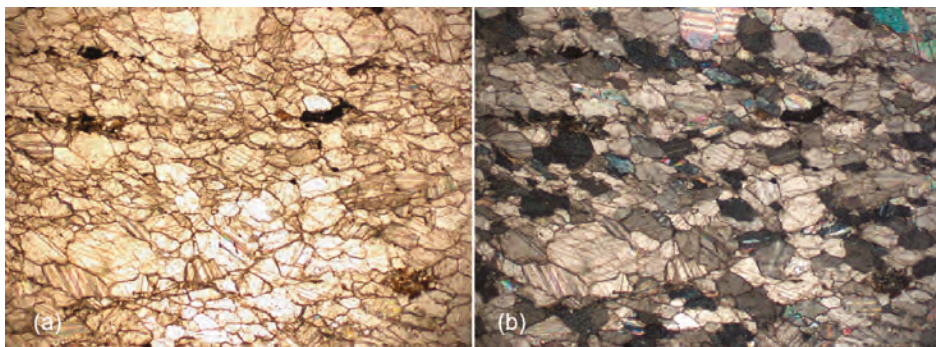
**Figure 12.** Macroscopic structure of sample 3 rock schistose marble: (a) With parallel nichols (b) With crossed nichols.

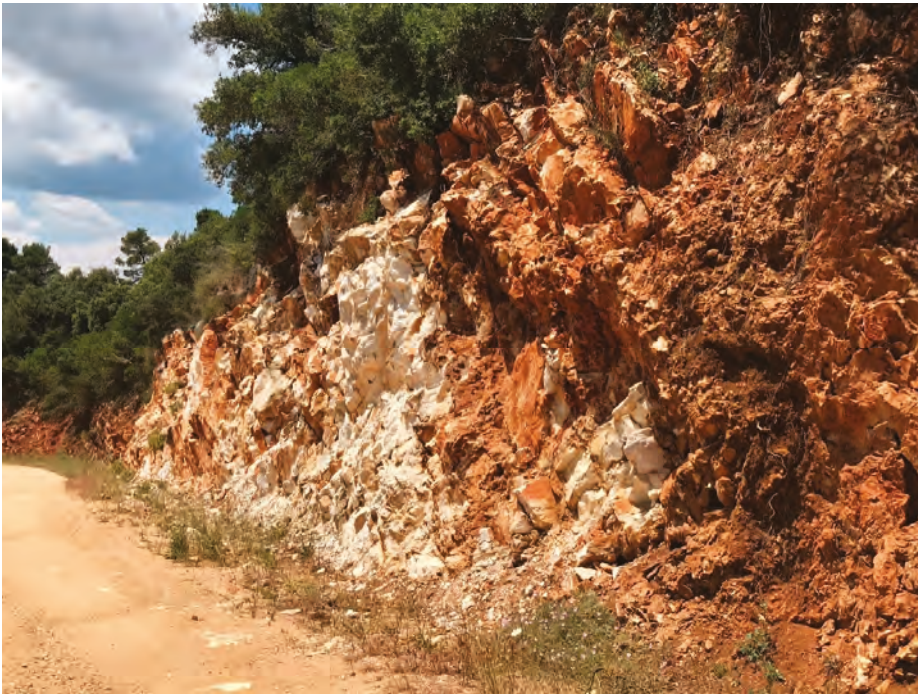
During the restoration of the Haybarn Complex, in addition to the use of the local stone as a building material, the stone taken from the stone deposit in a road, cut below Papa Konaki, near the Hilandar monastery (Figure 3) was also used. The petrographic composition of this stone is the same as the stone used as a building material for the entire complex at the beginning of the 19th century.

**Figure 3.** The stone deposit in a road-cut below Papa Konaki (provided photos taken by the author).

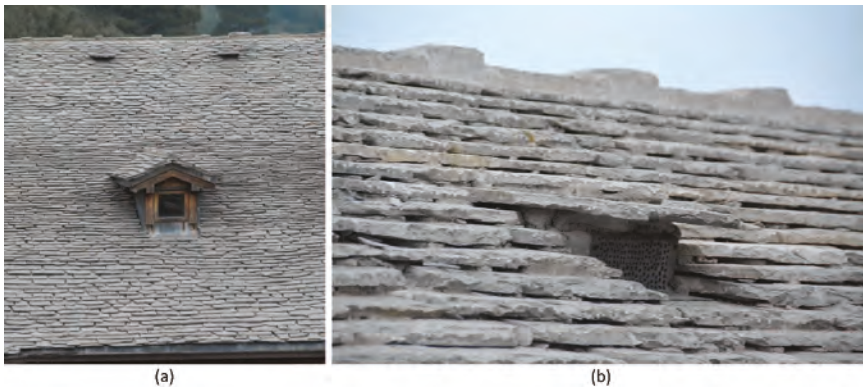
**Figure 10.** Venting during the restoration of the slate roofing: (a) roof appearance, (b) roof air vent (the photo taken by the author).

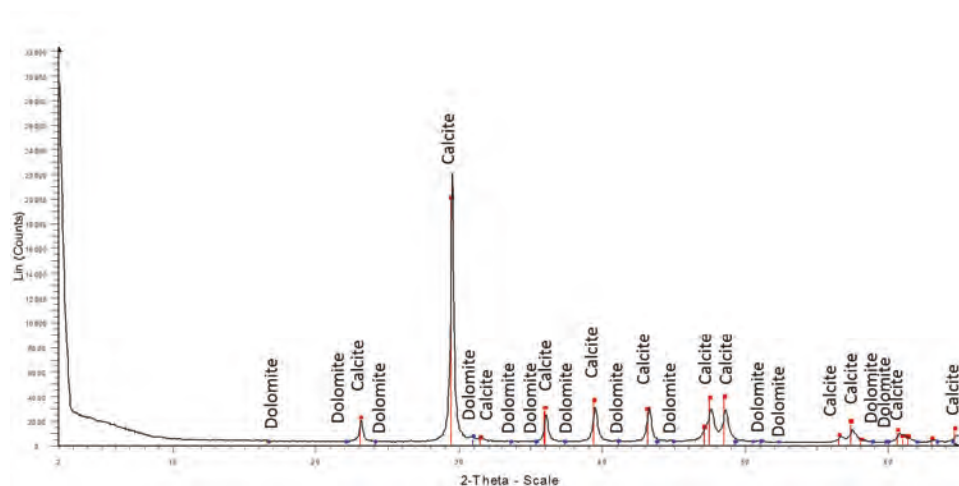
Figure 1. X-ray powder diffraction spectra of the marble selected.

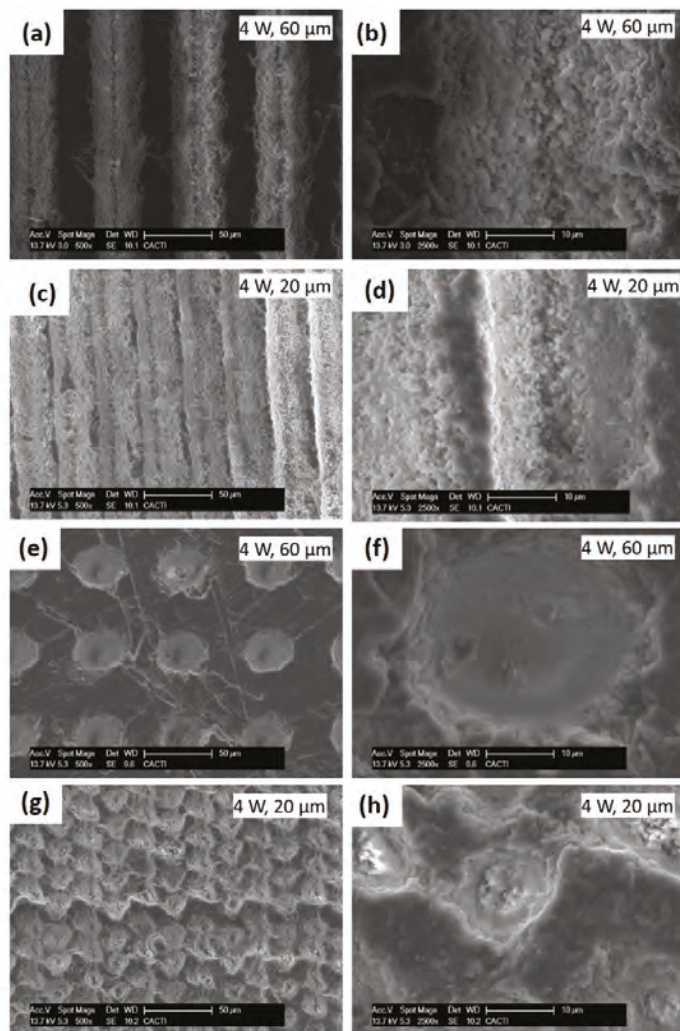
**Figure 4.** SEM micrographs of some of the laser textured surfaces treated under different conditions of power and pitch. (a–d): treated with grooves. (e–h): treated with holes.

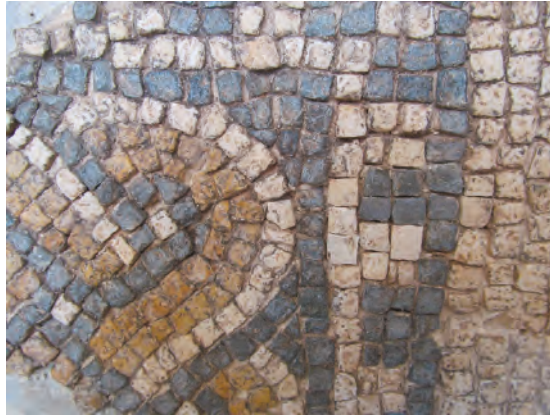
**Figure 2.** Roman mosaics retrieved from the Royal Palace during archaeological excavations. The yellow tesserae correspond to dolostone.

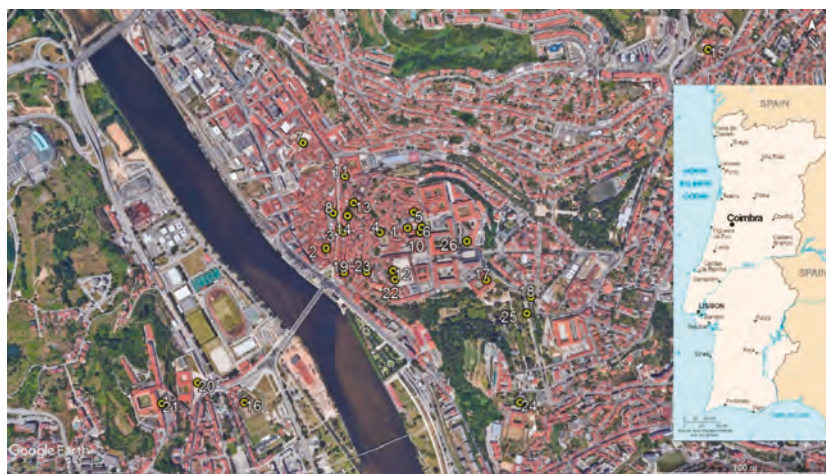
**Figure 4.** Principal monuments and building where dolostone was used. (1) Cryptoporticus of Aeminium; (2) S. Bartolomeu Church; (3) Almedina Tower (city wall); (4) Old Cathedral; (5) S. Salvador Church; (6) Mozarabe Arch; (7) Santa Justa Church (old); (8) S. Tiago Church; (9) Almedina Arch and Gate (city wall); (10) S. João de Almedina Church; (11) Santa Cruz Monastery; (12) S. Miguel Chapel; (13) Anto Tower (city wall); (14) Contenda Tower (Sub-ripas Palace) (city wall); (15) Celas Monastery; (16) Santa Clara-a-Velha Monastery; (17) S. Bento College; (18) S. Sebastião Aqueduct; (19) Santo António da Estrela Church; (20) S. Francisco Convent; (21) Santa Clara-a-Nova Monastery; (22) Baroque Library; (23) Grilos Palace; (24) Catholic Major Seminary of Coimbra; (25) Botanic Garden.

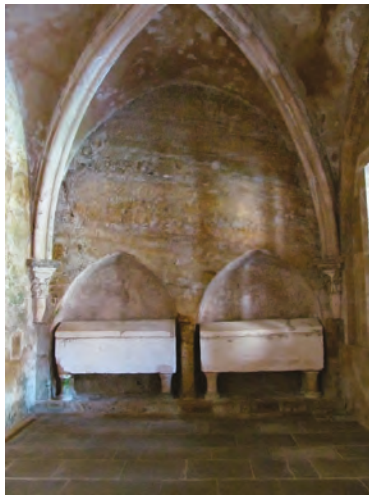
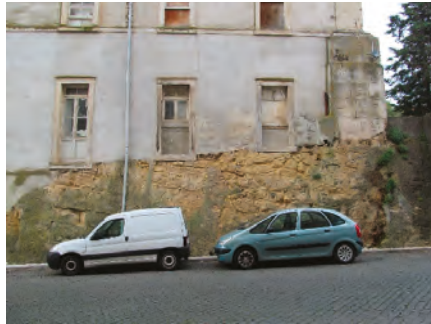
**Figure 9.** Examples of outcrops: (a) Santa Maria chapel, Old Cathedral, where the in situ stone can be observed; (b) Outcrop in College of Arts, close to the location of *Largo da Feira* quarry (below these locations) and S. Sebastião quarry.

Dolostone was used in the stonework on the facades and structural pieces in the interior, such as vaults and columns, in the monuments constructed during the 12th and 13th centuries. In this period, it was used with some frequency in decorative pieces, particularly in contrast to white painted walls giving rise to a gilded aspect (Figure 10). Contrast was also created when, centuries later, the Ançã Stone was used due to its very noticeable white colour. In some of these monuments, it is still possible to identify the geological registry of the outcrops in its interior, as is the example of the Old Cathedral (Figure 9a).

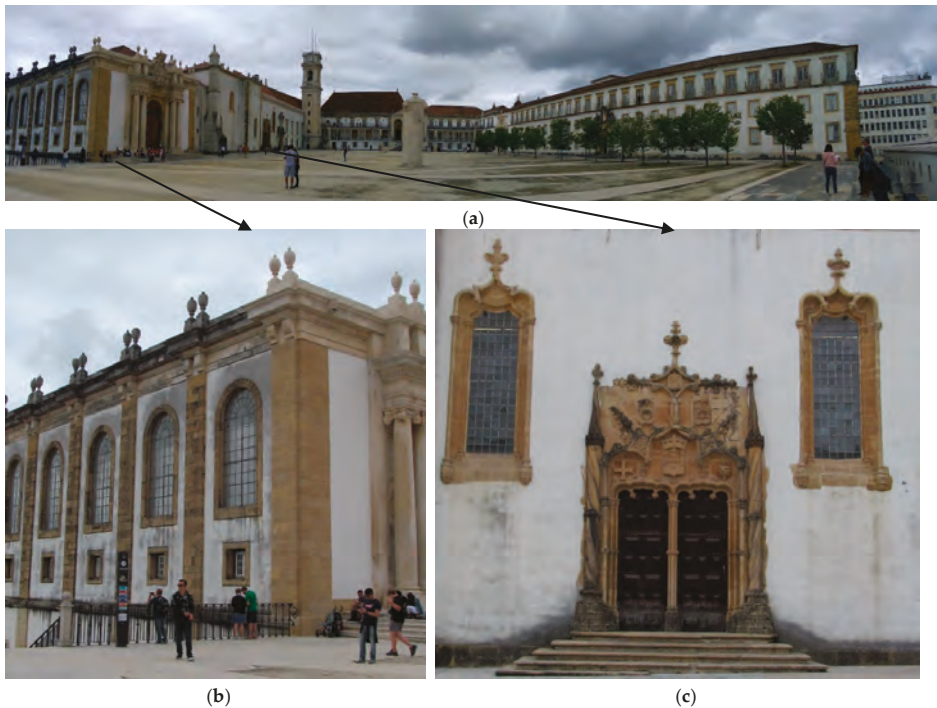
**Figure 10.** Overview of Royal Palace (a) and detail of Baroque Library (b) and S. Miguel Chapel (c).

The dolostone use in the monuments, built between the 16th and 18th centuries, is only visible in the quoins and pilasters. In these buildings, dolostone was also applied in masonry on the outer walls, and lintel around the windows and doors. The gilded aspect also presents a contrast with the surrounding white walls.

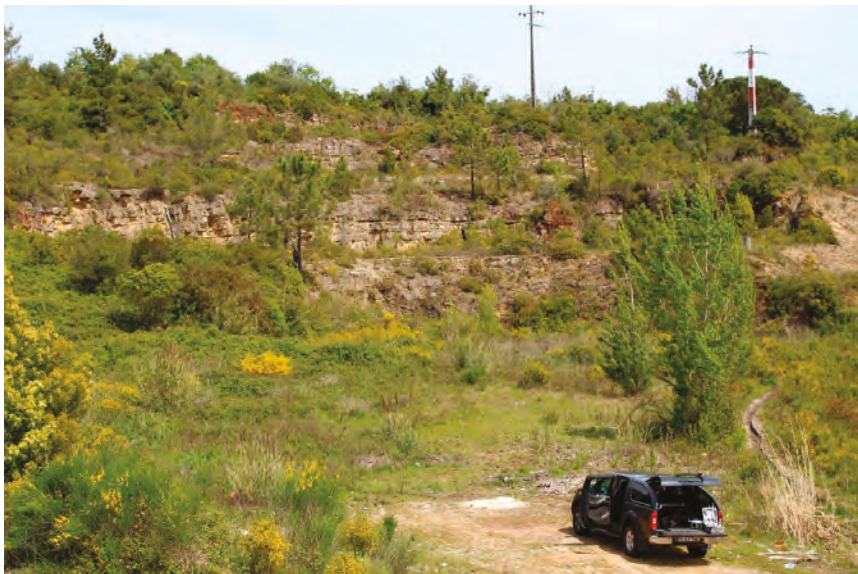
**Figure 11.** Example of an old quarry that allows the exploitation of blocks for conservation, restoration and rehabilitation of monuments (40°10'54.4" N 8°26'37.3" W).

Considering that most of the old buildings of Coimbra are included in the UNESCO World Heritage List, it is important to preserve the heritage and the materiality of the city. Taking into account the existence of several outcrops in the Santa Clara region that corresponds to old quarries, some of them exploited up to the last twenty years for the production of aggregates; it is possible to use, with prudence and vigilance from the authorities, stone from those quarries. The one presented in Figure 11, corresponds to the indicated as *d* (yellow dot) on Figure 8, due to the easy access to trucks and to the occurrence of stone with good quality has great relevance for this use. The other quarries signalized in Figure 6 also present proper stone, but due to the location near houses or monastery (Santa Clara-a-Nova Monastery) and with difficult accessibility, are less recommended for this use.

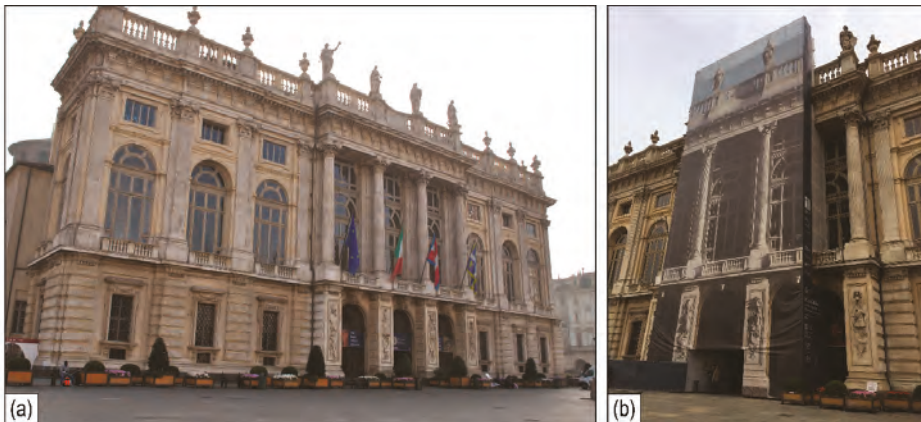
**Figure 1.** Buildings: (a) View of the Palazzo Madama façade; (b) Study site located in the central area of the façade.

One of the most prestigious buildings in Turin is certainly the Palazzo Madama (Figure 1a), a historical and architectural complex located in the center of the town. It is an UNESCO World Heritage site and at present is the seat of the city Ancient Art Museum. It is the testimony of two thousand years of history: Originally built by the Romans as a gateway to the town, the building became first a defensive system, and then a symbol of power until the sixteenth century, when it was replaced by the Palazzo Reale as seat of the Duke of Savoy. With King Carlo Alberto, politics also entered Palazzo Madama: In 1848, the king placed the Subalpine Senate in the large hall on the first floor, destined to become one of the places of politics in which Italy's unity was most strongly configured. Considerably embellished under the regency of the two royal ladies also known as "Madame" (hence the name): Maria Cristina of France and Maria Giovanna Battista of Savoy, the old medieval castle was retrained by the work of Filippo Juvarra, who realized (1718–1721) the great façade which dominates the square [6,7]. He chose the Chianocco marble, a yellowish grey marble from the Susa Valley, for coating the façade. The strong deterioration of this marble made necessary, over time, several restorations and replacements by different stone materials recalling the original one, but coming from different sources [8,9]. As a consequence, many archaeometric studies carried out on the façade of Palazzo Madama resulted in contradictory and partially wrong conclusions in the attribution of the stones employed over the centuries [10,11].

For this reason, and because of many recent conservation issues, the conservation and restoration foundation "La Venaria Reale", in collaboration with the Foundation Torino Musei and under the supervision of the Superintendence of Archeology, Fine Arts and Landscape for the Metropolitan City of Torino promoted several technical and scientific investigations in order to develop a pilot project for the overall conservation and future maintenance of the historical façade (Figure 1b).

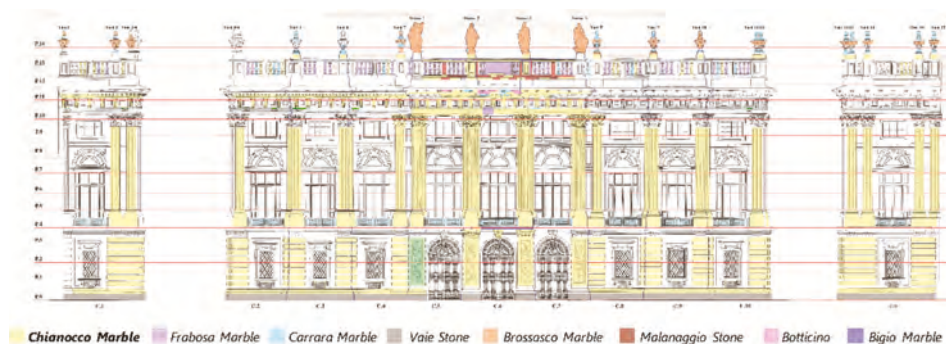
**Figure 3.** Petro-architectonic relief in false color representation of the Palazzo Madama façade (architectural drawings courtesy of Foundation Torino Musei-Palazzo Madama).

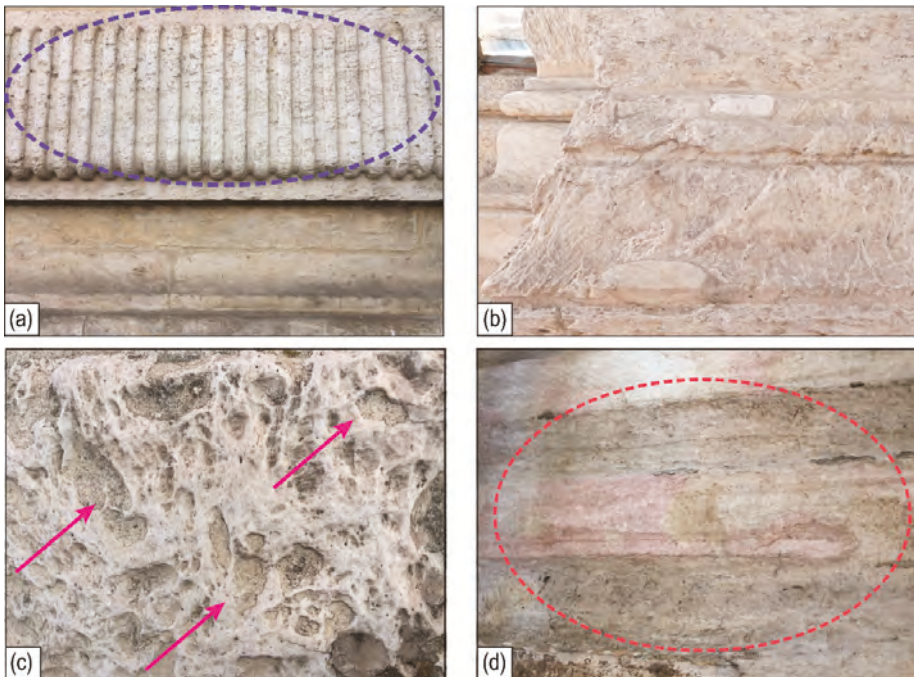
**Figure 4.** Characteristics of Chianocco marble macroscopically observed on the Palazzo Madama façade: (a) Slab of the façade with a strongly vacuolar texture; (b) Brecciated fabric with a pervasive vein network observed on a base of column of the façade; (c) Presence of mortars in the pores of the stone; (d) Detail of the reddish alteration of the column of the façade.

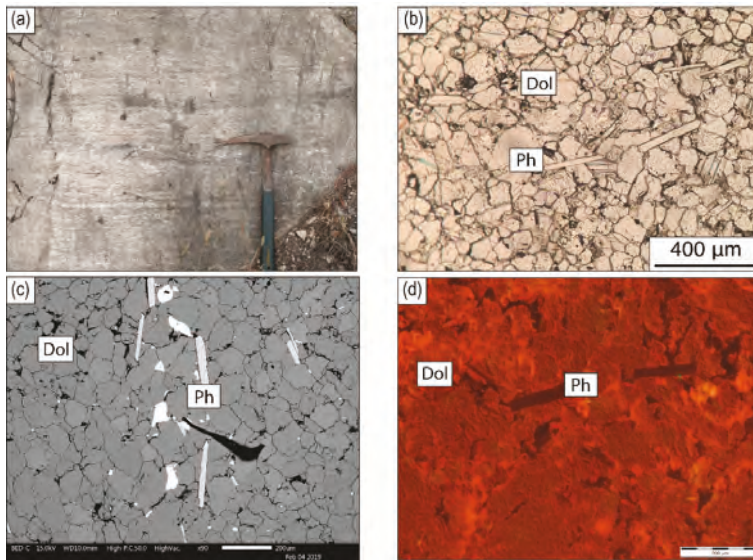
**Figure 5.** Petrography of the marble of Site 3: (a) Macroscopic aspect of the marble at Site 3; (b) Photo of optical microscope with only a polarizer, in which dolomite and phengite crystals are indicated; (c) SEM backscattered image. Dolomite crystals are dark grey and phengite ones are light-grey; (d) Cathodoluminescence image where dolomite crystals appear red and phengite crystals brown.

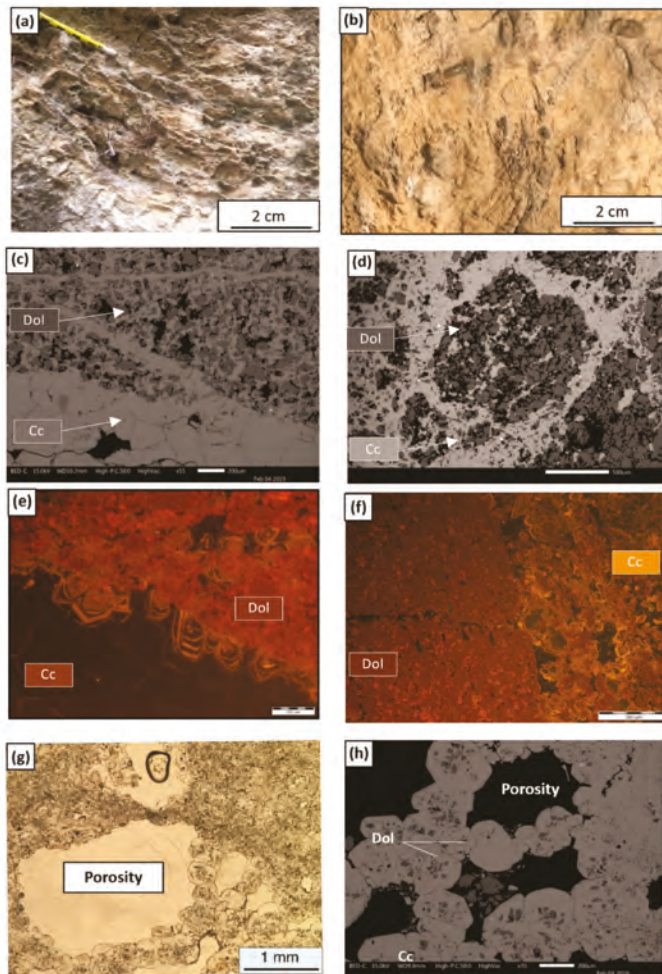
**Figure 6.** Petrography of Chianocco marble: (a, b) Macroscopic aspect of Chianocco marble; (c) SEM backscattered image where calcite veins are clearly visible; (d) SEM backscattered image where cataclastic structure is evident; (e) Cathodoluminescence image where in a calcite vein a zoning is recognizable with the very first portion of crystals characterized by thin bands of bright to moderate yellow; (f) Cathodoluminescence image where different dolomite, in red, and calcite, in black and yellow, portions are recognizable; (g) Optical microscope image with only a polarizer, with evident vacuolar texture; (h) SEM backscattered image where the voids are surrounded by calcite septa that originally separated the dolomite clasts.

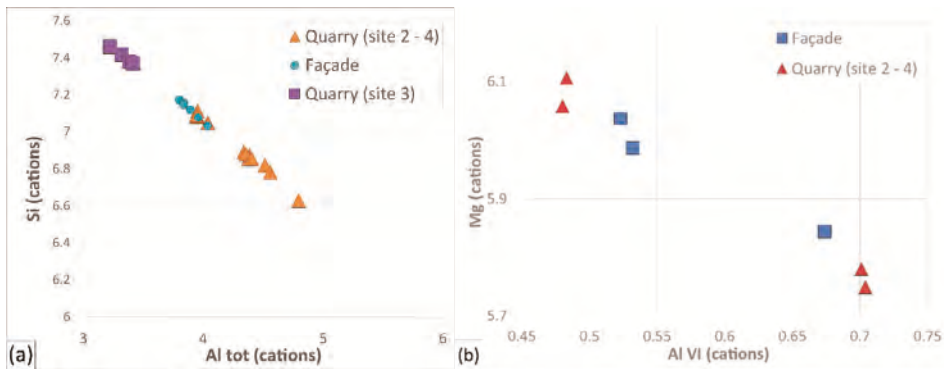
Figure 8. The Palazzo Madama façade and Chianocco quarry: (a) Si-Al tot classification diagram for white mica of the Chianocco marble from the Palazzo Madama façade and Chianocco quarry; (b) Mg-AlVI classification diagram for phlogopite of the Chianocco marble from the Palazzo Madama façade and Chianocco quarry.

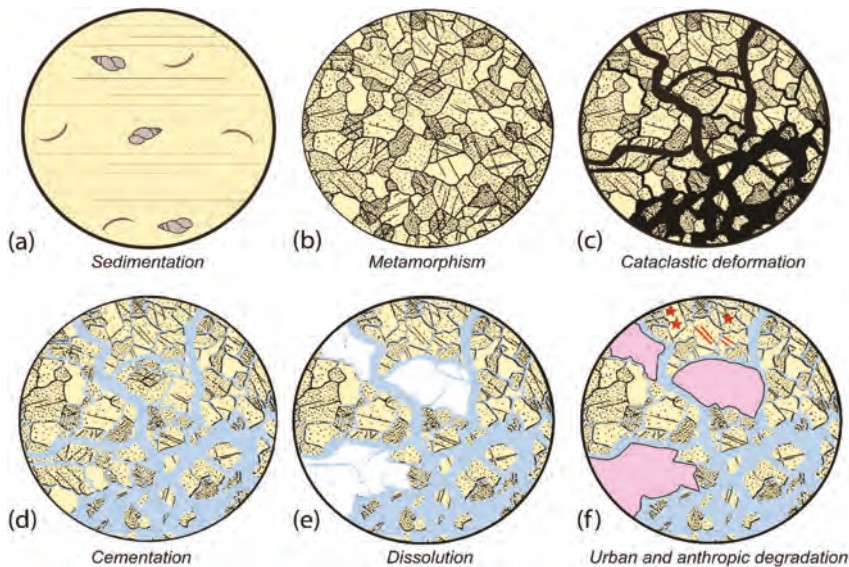
**Figure 12.** Representation of the model evolution of Chianocco marble from its formation to its employment: (a) Original dolostone; (b) Dolomitic marble; (c) Brittle deformation indicated by black fractures; (d) Cementation indicated in light blue color (tectonic carbonate breccia with a complex and pervasive cataclastic fabric); (e) Selective dissolution of dolomite marble clasts indicated in white (vacuolar texture); (f) Mortars in the pores indicated in pink and sulphation indicated in red stars, circles and lines in the upper part of the round.

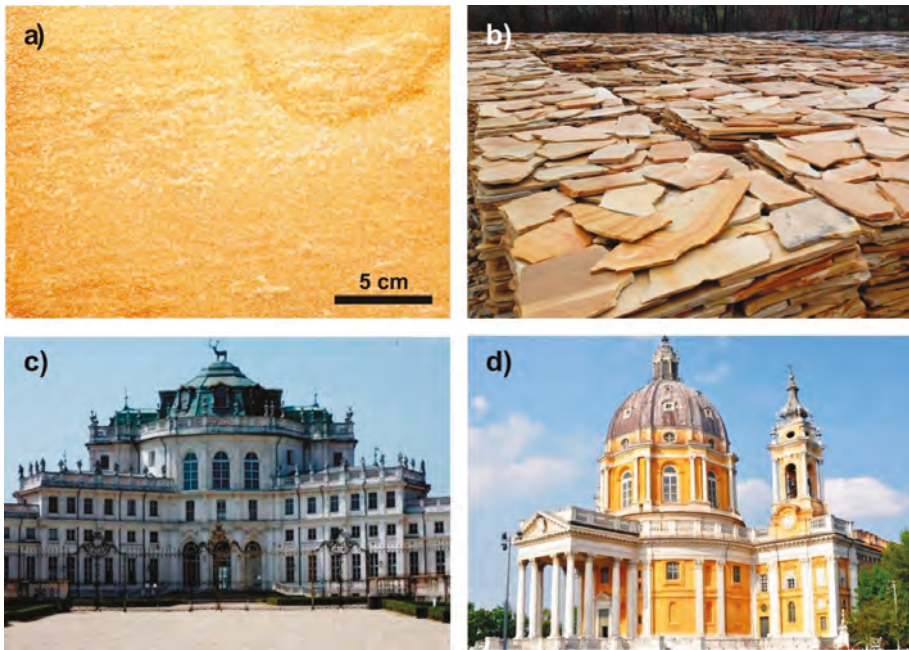
**Figure 2.** (a) “Golden” quartzite slab; (b) stacked quartzite slabs on the quarry floor; (c) Stupinigi hunting lodge (district of Nichelino in Turin); and (d) Superga basilica (Turin).

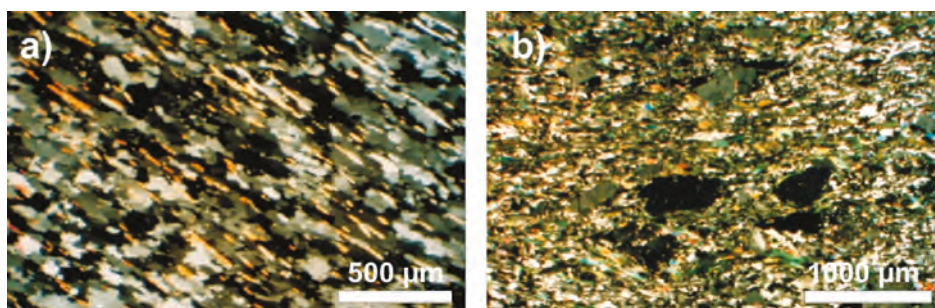
**Figure 4.** Thin section photomicrographs (cross polarized light) of (a) “golden” quartzite and (b) the *Marmorina* variety.

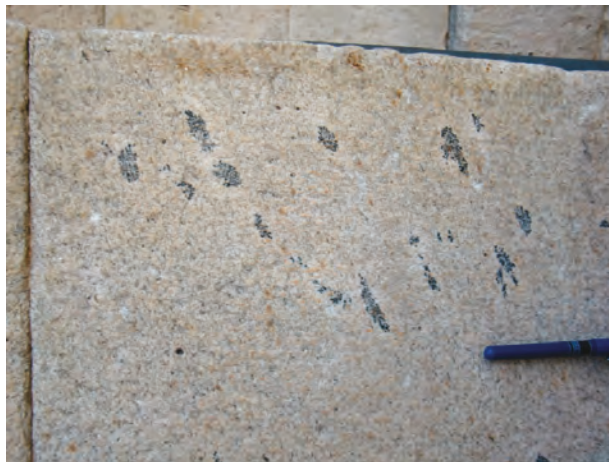
**Figure 2.** Texture of the granite. The cumulates of tourmaline resemble flying birds.

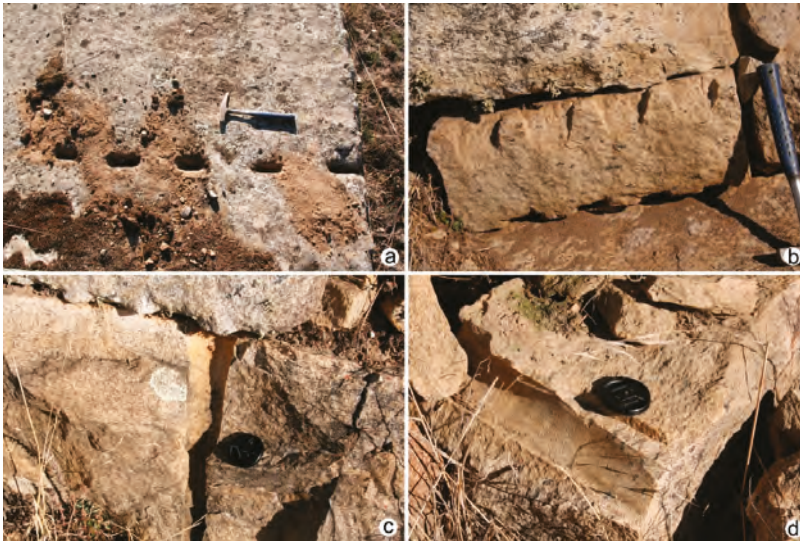
**Figure 5.** Splitting marks in ancient quarries of Martinamor granite: (a,b) wedge (rectangular) marks and (c,d) triangular-shaped drill holes.

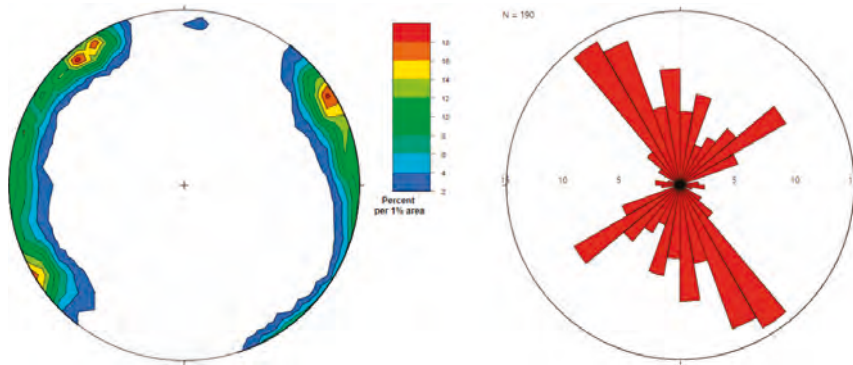
Figure 6. Distribution of the joints measured in the field work ( $n = 190$ ; low hemisphere).

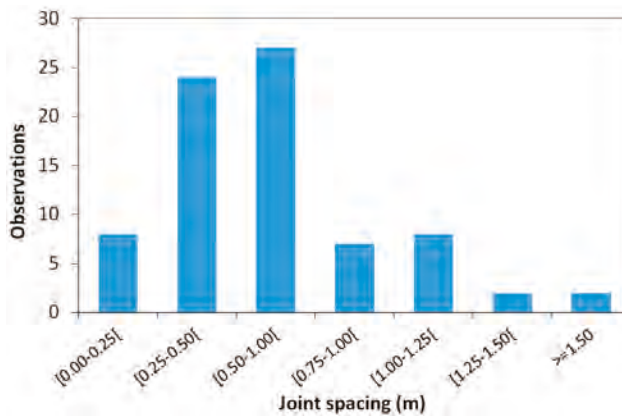
Figure 7. Distribution of the joint spacing data from field measurements.

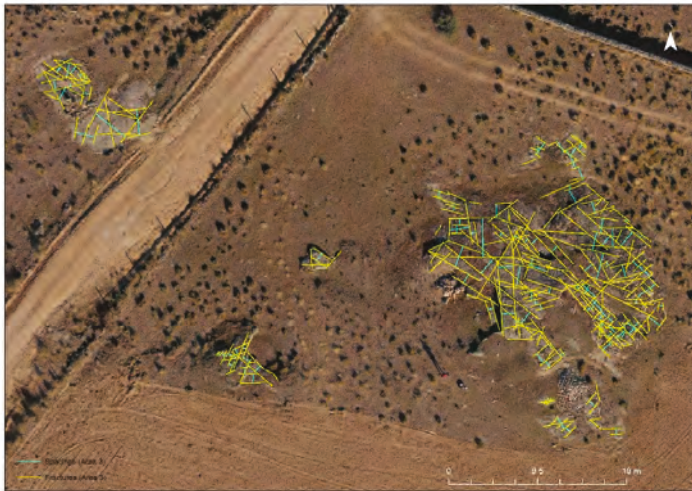
**Figure 8.** Example of fracturing identification in aerial photomosaic (yellow lines, joints; green lines, joint spacing).

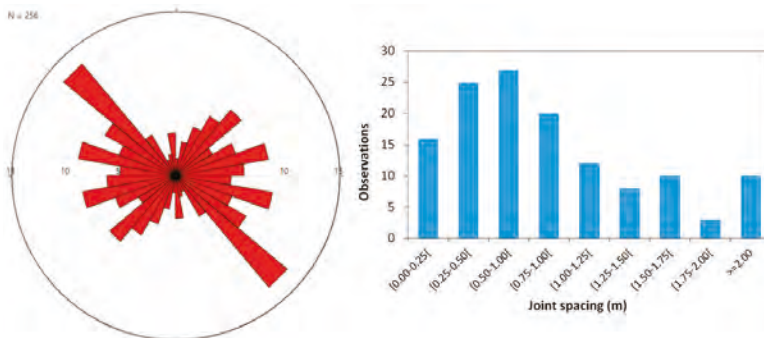
**Figure 9.** Fractures and joint spacing data from outcrops identified in Figure 8.

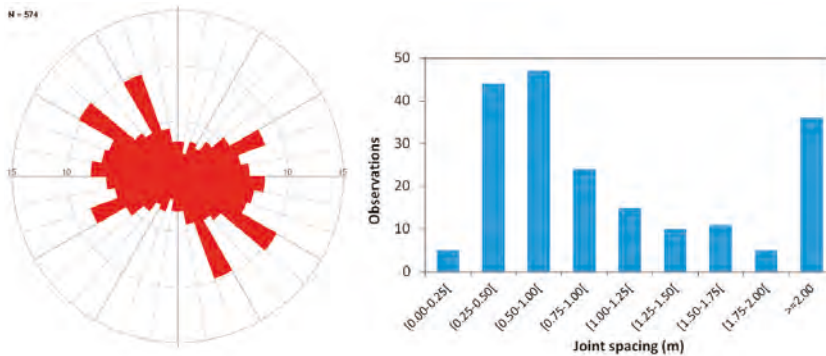
**Figure 10.** Rose diagram and joint space distribution relative to outcrops located near the ancient quarries (see Figure 3).

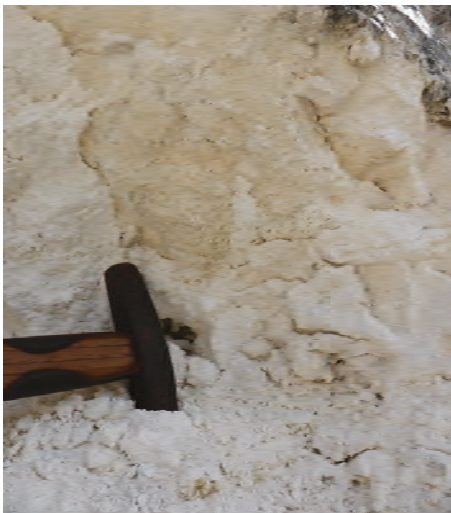
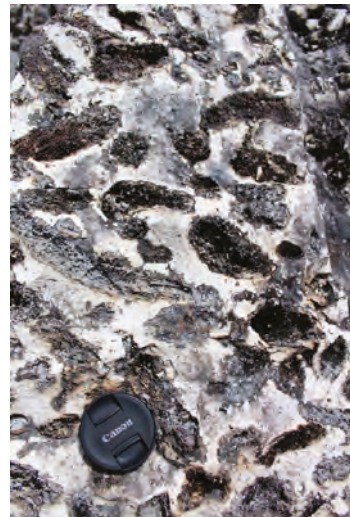
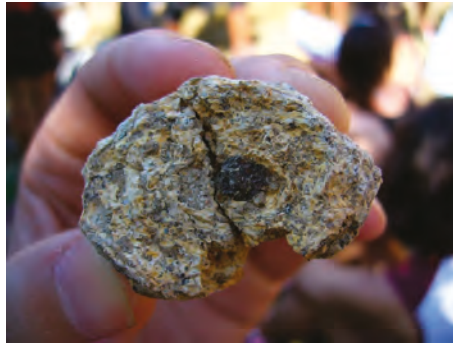
**Figure 7.** (a) Reefal limestone in Delair quarry, Grande Terre. Note the large *Agaricia sp.* fossil colony above the hammer. Unit 3-Lower coral limestones; (b) *Acropora sp.* reefal limestone in Delair quarry. Unit 4-Upper coral limestones; (c) Rodolith from Unit 1-Lower red algal limestones, Grande Terre, Guadeloupe. Note the red algal carbonate concentric deposits around the volcanic debris.

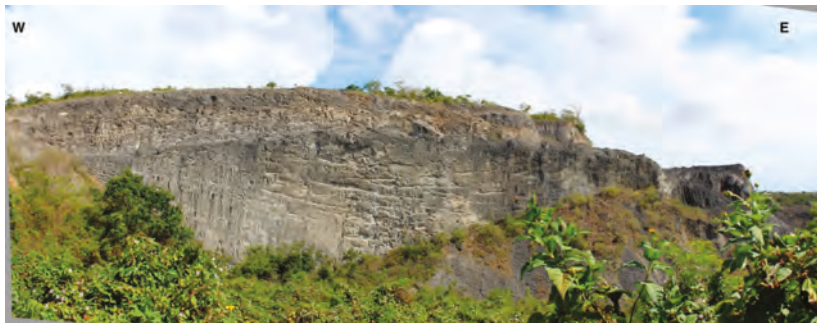
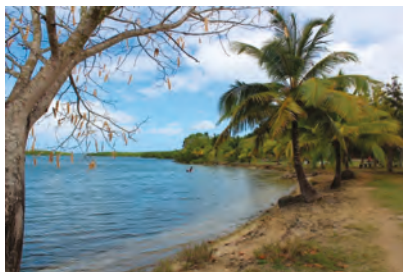
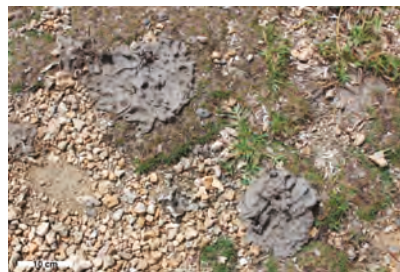
**Figure 8.** (a) view from the south of the protected outcrop at Delair quarry, in Guadeloupe, in 2010. Several sedimentological facies were identifiable. The height of the escarpment is of 40 m; (b) view from the south-west of the same outcrop in 2019. Surface alteration has darkened the rocks, the structures are far less visible and a pile of materials from the quarry is blocking the access to the escarpment; (c) the bay of Babin, in Guadeloupe; (d) mud collected at the sea bottom for mud bathing and let onshore after use.

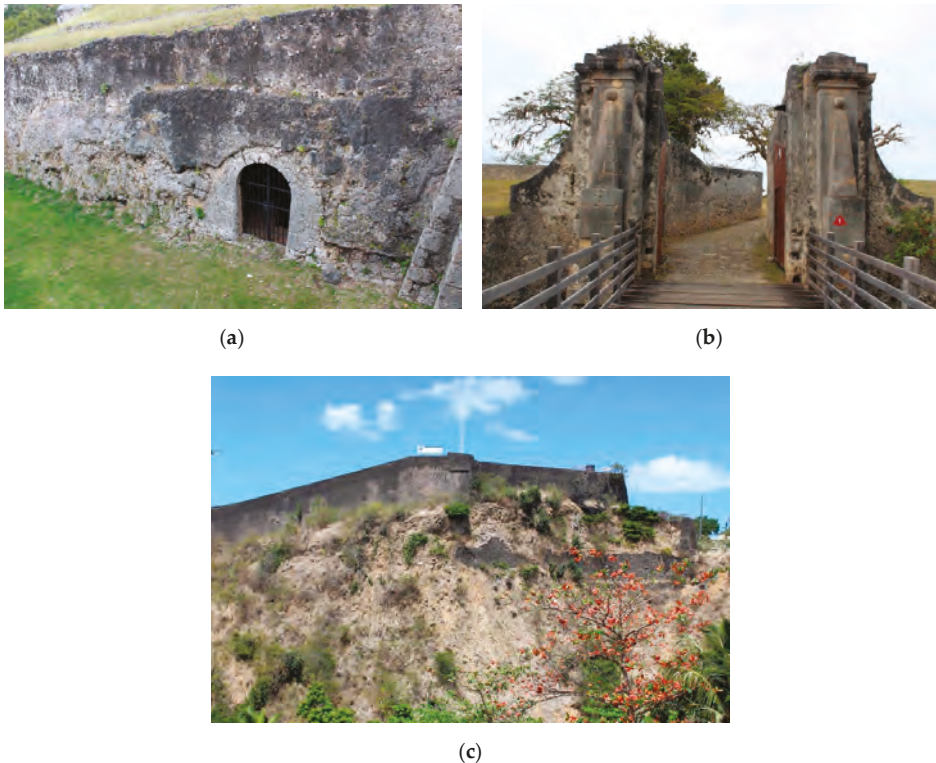
**Figure 9.** (a) Foundations of the Fort Fleur d’Épée, Guadeloupe. Entrance of a tunnel, excavated in the limestones, and inner wall of the fort, directly on the rocks; (b) main gate of Fort Fleur d’Épée with dimension stone ornamentations made with Basse Terre andesite; (c) northern fortifications of Fort Delgrès, Guadeloupe, above the gorge of Galion river. Note the unconsolidated debris flow materials, from La Soufrière volcano, forming the escarpment.
