# Natural Stone and Architectural Heritage

Edited by  
Lola Pereira, Lidia Catarino and Giovanna Antonella Dino  
Printed Edition of the Special Issue Published in *Sustainability*

Special Issue Editors

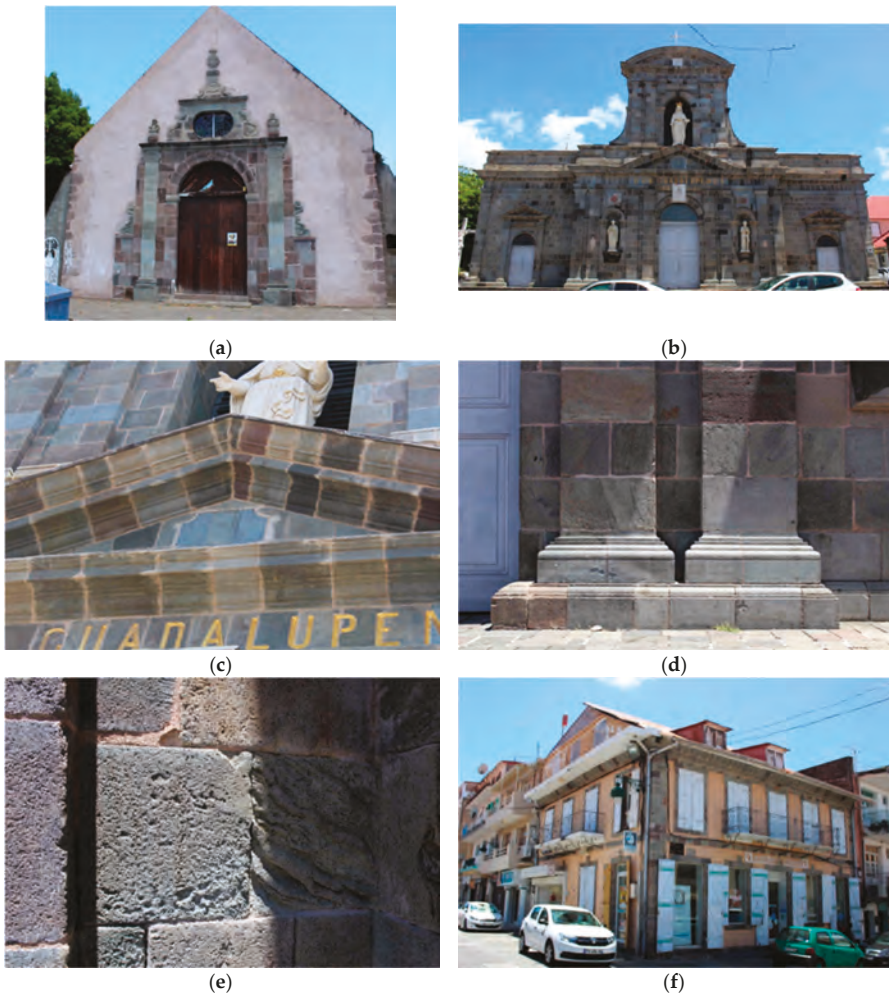
**Figure 10.** (a) facade of the Vieux Habitants church; (b) facade of the Basse Terre cathedral; (c) and (d) architectural elements of the Basse Terre cathedral; (e) rock alteration on the Basse Terre cathedral; (f) Basse Terre city center house, in front of the cathedral.

The preservation state of the materials of the buildings in the center of Basse Terre city, and especially the Basse Terre cathedral, shows highly variable deteriorations of the dimension stones. Although the origin of the blocks is uncertain, their coloration, the important variability of textures and the abundance of vacuoles suggest a provenance from the slightly weathered top of Basse Terre lava flows (Figure 10e). The deterioration is particularly important where the porosity of the material is high. Alteration also strongly follows the fabric of the material, especially the magmatic fluidity. This implies that for the eventual restoration of the cathedral, it will be likely that the use of andesite

blocks from local lava flows or debris flow deposits will be required. Indeed, the andesitic rocks currently in exploitation at the quarry in northern Basse Terre are of different quality (color, fabric) and would presumably show a strong appearance difference with the stones used for the original construction of the building.

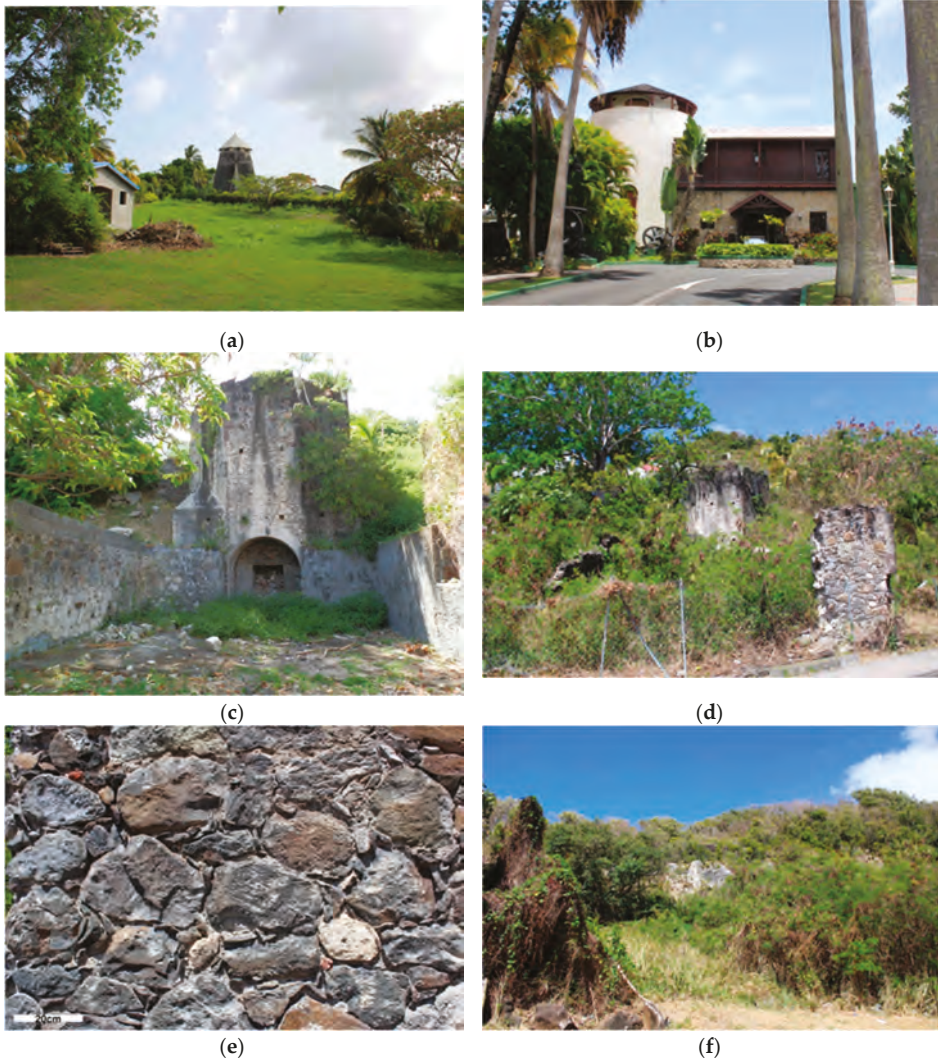
**Figure 12.** (a) typical landscape in Grande Terre, with a former sugar cane windmill, in Saint François; (b) example of a restored windmill and adjacent building, used as the main entrance of a hotel, in Le Gosier; (c) photograph of the Trois Rivières limekiln, taken in 2012 [35] and in 2019 (d); (e) detail of the walls of the limekiln; (f) Pointe Glacis former quarry.

The industrial history of the West Indies is tightly linked to the culture of sugar cane. Thus, the main stone made industrial buildings are windmills and sugar factories. They are particularly abundant in Grande-Terre (eastern Guadeloupe) and Marie-Galante, where they are an important element of the landscapes [33]. Windmills are probably the natural stone architectural heritage that is the most identified as such within the population in the French West Indies. They are consequently rather well preserved and some are integrated in architectural projects, such as hotels and resorts (Figure 12a,b). For the production of lime, limekilns have been built in different places of the islands, near the resources. Some were even built on small islets where no rock outcrops above sea level (Ilet Fajou). They were using only materials extracted directly from the sea floor at shallow depth. Surprisingly, the most important in Guadeloupe is located not on the carbonated Grande Terre, but on the volcanic island of Basse Terre. It exploited the only limestone outcrop of this part of the island, in Trois Rivières, which consists in a lens of reefal limestones, interbedded with volcanic deposits. It had the advantage of being close to both the resource and the demand for lime of Basse Terre city. The limekiln is protected, but poorly maintained (Figure 12c–f) [34]. The former quarry (*Pointe Glacis*) is in the geosites inventory, but benefits from no protection measure and is currently covered with vegetation and not accessible easily.

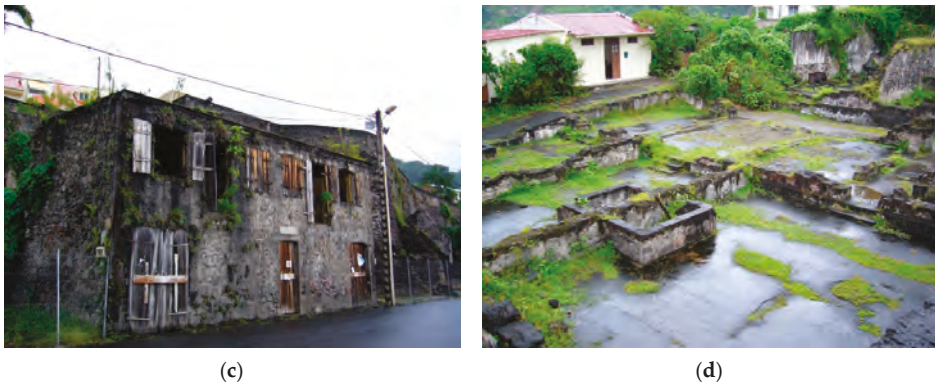
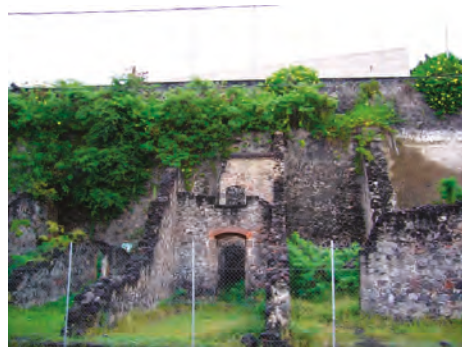
**Figure 13.** (a) Montagne Pelée volcano overlooking Saint Pierre; (b), (c) and (d) ruins of Saint Pierre, after the eruption of 1902.

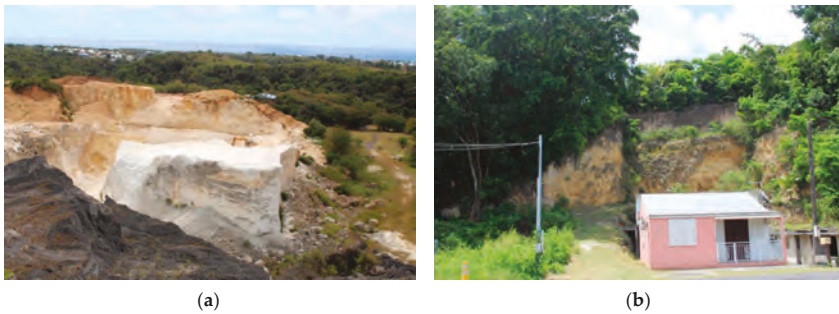
**Figure 14.** (a) Delair active quarry, in Les Grands Fonds area, Guadeloupe; (b) example of landscape transformation for individual houses building in Les Grands Fonds.

In order to follow the increasing demand, the production needs to rise and the impacted surface widens. On small territories, and the West Indies being a hotspot for biodiversity, this is a source of debate and conflicting interests within the society [48]. Recently, some quarries have been authorized to mine adjacent areas, providing they take biodiversity loss compensation measures [14]. Although the extraction of andesites, which requires mining techniques, is restricted to only a few sites, the softness of the carbonate platform limestones in Guadeloupe allows an easy mechanical extraction. In the Grands Fonds area, south of Grande Terre, Guadeloupe, seven authorized quarries are active and three others are located around the Grand Fonds and in Marie-Galante. However, in many places, the limestones are extracted without mining authorization, for earthwork purposes. The landscape appears to be strongly impacted (Figure 14).

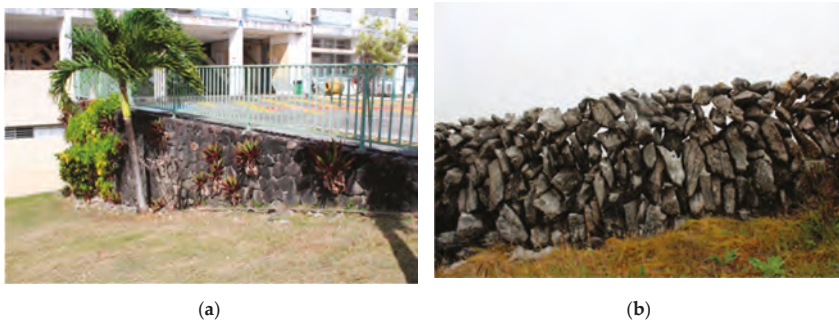
**Figure 15.** (a) 1970's natural stones wall in the University campus, Guadeloupe. To be compared with Figure 11c; (b) dry stone wall in the Burren, County Clare, Ireland. The stones are oriented in a manner that minimizes the resistance to the wind; (c) dry stone wall at the bottom of a hill in Saint Barthelemy; (d) modern road-side stone wall, Saint Barthelemy.

The transformation of the society in small island territories and the intense weathering of geomaterials under tropical climate are putting the preservation of the natural stone architectural heritage, as well as the geological natural heritage, under growing tension. In Martinique, the ruins of Saint Pierre are remarkable because of both the history of the destruction of the city and their rare dimension stone architecture. The volcanic crisis of 1902 and 1929, accelerated to the abandon of the architectural style of the 19th century and, with the use of modern materials, the know-how has not been transmitted. In Guadeloupe as well, the natural stone architectural heritage is poorly preserved and not all historical buildings benefit from a protection. However, many constructions demonstrating the preservation of the traditional know-how can be seen in the French West Indies. For example, some natural stones walls are still made with the same techniques as in the 17th to 19th century (Figure 15a). In Saint Barthélemy, preservation efforts are being made and stone walls are still being built and keep structuring the landscapes of the island. However, they are no longer used for field separation but rather along the roads. According to modern standards, these walls use natural stone, but not dry stone (Figure 15c,d). This solution, that doesn't follow the traditional building modes, has been favored for esthetical considerations as well as for preventing earth, dirt, or any objects to be wind-pushed on the road. Traditionally, dry stones walls were preferred in Saint Barthelemy, which allowed the rain water to flow downhill during the rainy season. Today, during the heavy rain events in Saint Barthelemy, the water occasionally accumulates along the road-side stone walls, sometimes damaging the soils and infrastructures. In Europe, in areas submitted to strong wind episodes, dry stones were also favored for their resistance, as the space between the stones allows the wind to go through. In the Burren, Ireland, the stones are oriented in a manner that minimizes the resistance to the wind and that leave significant empty spaces in the wall, in order to let the airflow easily (Figure 15b).

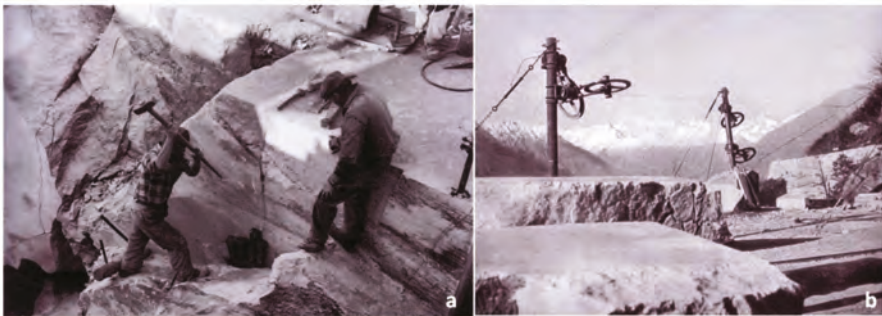
**Figure 6.** (a) Quarry worker with a sledgehammer, *punciotti* (plug and feather), and chisels. (b) Candoglia open pit yard: helicoidal wire. (Veneranda Fabbrica Historical Archive).

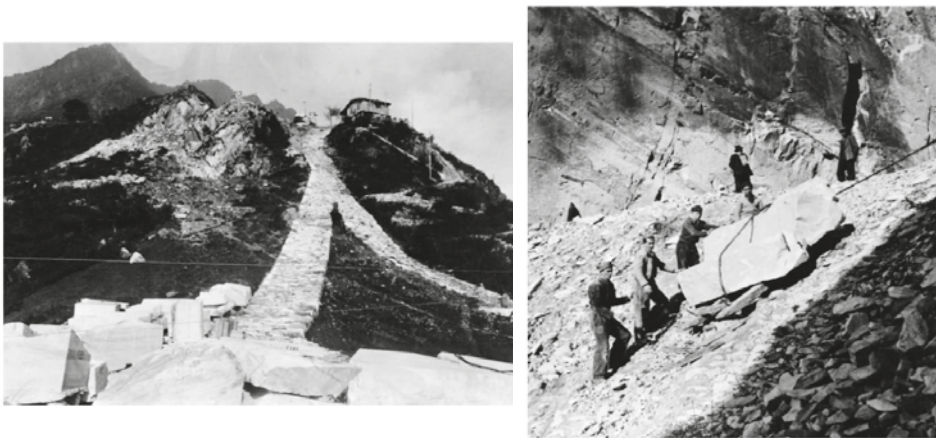
Figure 8. Running routes made of quarry waste (left) and big wooden sledges—“struse”—to transport the blocks from the quarry to the valley [29].

After being quarried and squared, the blocks were transported from the quarry to the manufacturing plants on running routes, thanks to the employment of large wooden sledges—“struse” (Figure 8). More recently (from the 1920), the “binda” (jack) or the derrick were used to move the blocks. The blocks were then transported to the river docks by means of wagons towed by pairs of oxen (Figure 9a). From the River Toce docks, the marble was transported to small manufacturing plants (Figure 9b), in Suna and Baveno (along Lake Maggiore); in these laboratories, all the locally exploited blocks were squared, cut and worked. It has to be highlighted that the first mechanized saw for blocks was built for the processing of Candoglia marble.

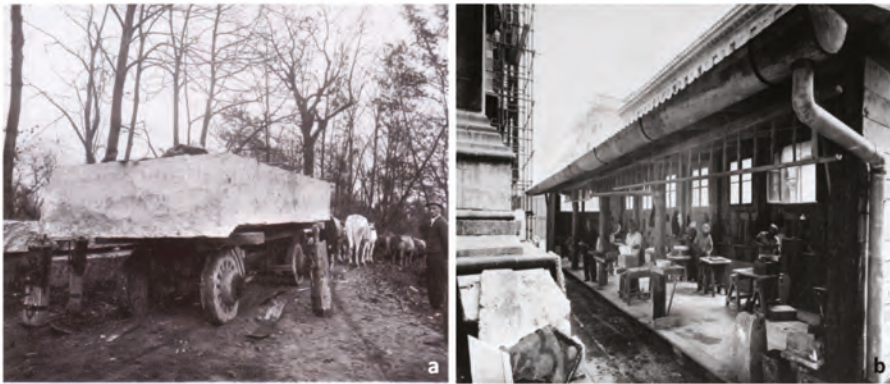
**Figure 9.** (a) Wagons towed by pairs of oxen which transported the blocks from the valley to the river pier. (b) Veneranda Fabbrica working yard in Milan (XIX–XX cent.) [29].

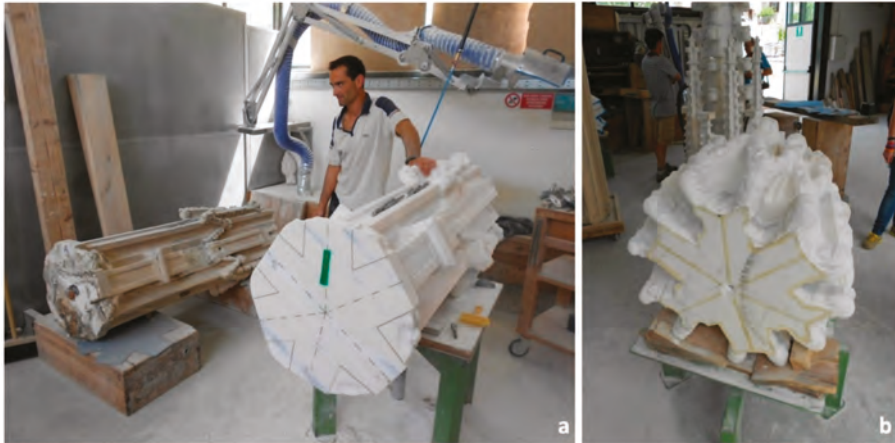
**Figure 11.** (a) Rough working sketch of the sculpture. (b) Chiselled sculpture to substitute the original one.

The squared blocks are sent to the main working plant near Milan to be mechanically worked for the production of a first rough sketch of the sculpture. After this rough working phase, the blocks are sent back to the Candoglia mason stone cutter laboratory (near the offices of the Venaranda Fabbrica del Duomo di Milano) to be chiselled by expert stone workers, to obtain the copy of the pieces to substitute (Figure 11).
